GRAMPAW PETTIBONE

Don't Kill Your Friends

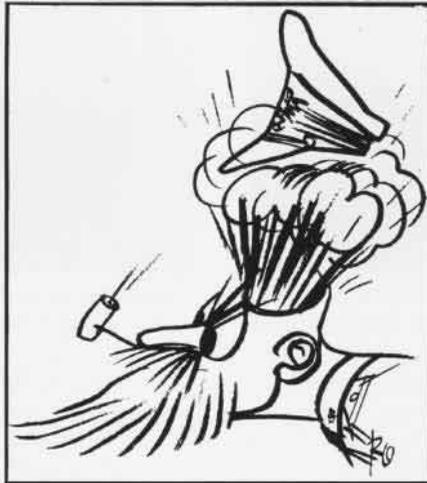
The pilot of an FH-1 checked his instrument gauges before take-off and they presented normal indications. During the run-up prior to releasing the brakes for take-off, the oil pressure reading was 75 pounds per square inch. Upon releasing brakes and initiating take-off roll, the pilot heard an explosion in the right nacelle. The compressor of the right engine shattered and some of the compressor rotating blades sheared off and pierced the compressor case and severed several electrical cables and dented the engine nacelle.

The accident board was of the opinion that this accident was caused by failure of the number one bearing *due to the lack of lubrication during prolonged inverted flight and probable inadvertent application of negative "G" by another pilot who had flown this plane earlier in the day.*

Here is the story behind the accident. The pilot who flew this FH-1 in the morning before the accident pulled off to one side of his formation and rolled over on his back. He remained inverted until the fuel warning lights came on and then rolled back to level flight. By the time he regained a normal position the fire had gone out in his port engine.

He picked up 200 knots and started the dead engine using the air-start switch. After he got this engine started, he noticed that the oil pressure on the starboard engine was fluctuating between 20 and 60 lbs per square inch. He immediately pulled the starboard throttle back to idle position and told the flight leader that he was returning to base which was about six miles away.

He did not use the right engine on the remainder of the flight except for a few seconds during his final approach. In reporting the discrepancies he simply wrote on the yellow sheet, "Oil pressure of right engine fluctuates." He did not specify the amount of the fluctuation or his other experiences with the plane until after the accident had occurred on the following flight.

Since it is normal for the oil pressure of the J-30 engine to vary or fluctuate with engine speed, the plane was only given a routine pre-flight check before releasing it for the afternoon flight on which the engine exploded.

onds later, however, he might have been in very serious trouble. Any time you have reason to believe that you may have injured an engine, or exceeded the "G" limits on a plane, or damaged it in any way, report the trouble in full as soon as you land. Don't kill your friends!

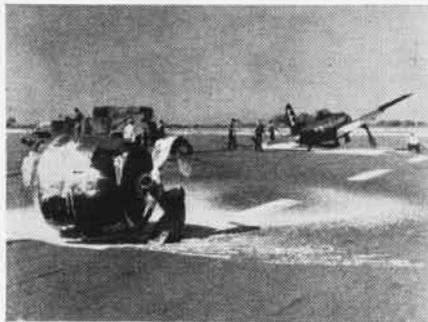
Where's My Engine?

The F8F above parted company with its engine shortly after the second bounce in a slipstream landing accident. The pilot states that he was maintaining 85 to 90 knots in his approach when he hit the slipstream of the plane ahead. He was then 300 feet from the end of the runway and at an altitude of about 35 feet.

The plane went into a 70 degree bank with the left wing down and despite corrective action hit some 200 feet short of the runway. The left landing gear buckled on this impact, and the prop dug in on the second impact. The engine was torn out of its mounts and went bouncing up the runway ahead of the plane. Meanwhile the F8F slid up on the runway, spun around, and stopped about 200 degrees off its initial heading. MORAL: DON'T GET TOO CLOSE TO THE PLANE LANDING AHEAD.

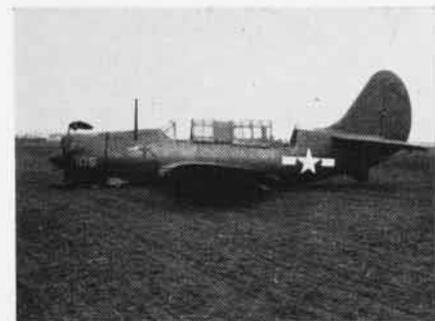
The pilot of an SB2C-4 took off from Aberdeen, South Dakota for NAS MINNEAPOLIS with enough fuel in his plane for an estimated 1 1/2 hours of flight. The distance to be covered was about 265 miles. After fifty minutes in the air the pilot discovered that he had drifted south of his intended course, and attempted to check his position on the Minneapolis range. He was still quite some distance from the station and all he could pick up was static. He had been flying at 8000 feet and 185 knots, but at this time he decided to get down low in the hopes of spotting the name of a town or city on a water-tower, or some similar marking.

Because he was at such a low altitude he failed to see any one of four airfields within a radius of 20 miles of his position. An hour and twenty minutes after

take-off, his fuel was exhausted and he made a wheels-up landing on a smooth plowed field.

This is another prize example of a flight that simply wasn't planned. Even with the most economical power settings, it is doubtful that the plane could have reached its destination with the fuel aboard at take-off. By flying at the high cruise power settings necessary to maintain 185 knots at 8000 feet, the pilot destroyed whatever slim chance he may have had of making it to Minneapolis.

Then to top off the whole miserable performance, he became lost despite excellent weather conditions. The spot where he made his forced landing was more than 100 miles from his destination.
