GRAMPAW PETTIBONE

This Month's Rough Ride

Life Is Brief Sans Briefing

Get the Shovel

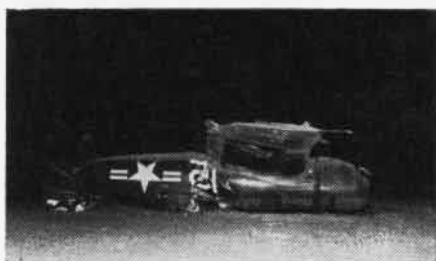
A pilot of the F4U-4B shown in the accompanying photo was the division leader of a four-plane night cross-country flight, which included a five minute stop at NAAS MIRAMAR. On this landing he broke off and made a normal approach to what he thought was runway 28. His vision of the runway was obstructed to an appreciable extent because of thin scattered clouds at 800 feet and ground fog in the gully through which ran two rows of high intensity approach lights. These red lights extended back from the head of runway 28 for a distance of 2000 feet and are the same width as the runway.

The aircraft made contact with the ground in a normal landing attitude approximately 400 feet short of the runway. The wheels were broken off by the initial impact which was with the top portion of a six-foot embankment. The plane then bounced forward 72 feet at which time the propeller began digging in. About 44 feet further the propeller left the aircraft and the landing gear strut stubs began digging in. This flipped the Corsair into the air and over on its back for a 40-foot slide.

The Accident Board states that the pilot mistook the two rows of red lights for the service runway. He had only a

brief vision of the entire field before pulling up the plane's nose into a landing attitude. This accounted for his not seeing the green lights across the end of the service runway. The ground fog in the gully dimmed the intensity of the red lights to such an extent that the pilot failed to recognize their true color.

Interrogation of other pilots on the same flight disclosed that they experienced the same confusion regarding the true limits of the runway, and could have suffered similar mishaps had they been allowed to make their approaches. The Board also notes that this pilot was making his first night landing at this field and was not briefed regarding the additional lighting facilities. He had, however, made a daylight landing at this field a week previously.

Don't be overconfident about landing at a field at night, merely because you've been there once in the daytime. Things have a way of looking a lot different at night, especially when you throw in a little fog, smoke, or haze. Avoid confusion by insisting on a THOROUGH BRIEFING.
