GRAMPAW PETTIBONE

Booby Trap Dept.

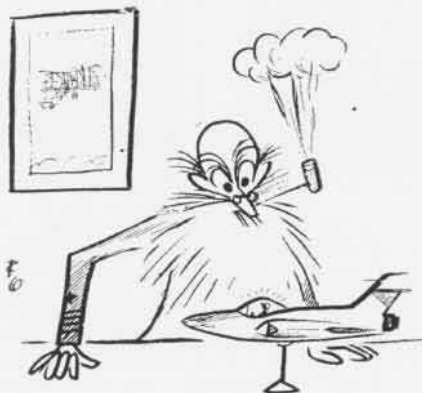
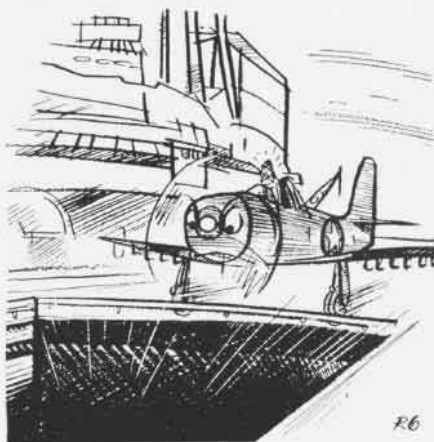
Case #2

As the F4U-4 taxied forward out of the arresting gear, the pilot raised flaps and began to fold his wings. However as he crossed the barriers, FLY TWO gave the signal to unfold wings. After glancing at a PRIMARY FLY, FLY TWO then gave the flaps down signal, followed by the turn-up signal. The pilot indicated that he was ready, after which he was given the launching signal.

The F4U started down the deck, and the pilot's first indication of danger came when he saw numerous members of the flight deck crew scampering for the catwalks. As the tail came up he saw the two planes on the port and starboard catapults, and hit the brakes.

The F4U skidded from the 275-foot position to the 160 foot position where it crashed between and into the two planes on the catapults.

All three F4U's were severely damaged and will require major overhauls. Fortunately no one was injured.

of flight operations following the recommissioning of the carrier. It was caused by haste and inexperience on the part of the flight deck personnel. FLY TWO apparently launched the aircraft without visually checking the forward deck. Neither bull horn, yodel, or radio was employed by PRIMARY FLY to warn pilot and deck crew of impending danger.

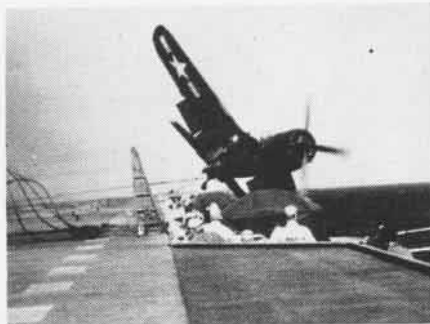
Who Stacked the Deck?

If you look closely you can see that this *Corsair* has snagged a wire although the pilot is trying to take a wave-off. The plane went on over the side and hit with full power. The pilot crawled out with a bruised knee and was picked up seconds later by the plane guard.

There's more to this accident than meets the eye. Of course, the pilot erred when he anticipated a cut and took off some power only to realize that he was getting a wave-off.

However, the accident board notes that due to a combination of circumstances this pilot had not been given any FCLP during the week prior to his initial qualification aboard the carrier. He lost a couple of these days in transit, and a couple more when he was confined with the flu.

The carrier was heading into the early morning sun at the time the qualification exercises began. The plane just ahead of this F4U blew a tire on a hard landing and the other planes in the pattern circled until the deck was clear.

As he approached the ramp, the pilot had difficulty seeing the Landing Signal Officer. In an attempt to get a better view he extended his head outside the cockpit. This probably caused him to lower his left wing and add more right rudder, which set up a skid to the left. At the same time the pilot eased off throttle which resulted in the airplane settling at the ramp. The pilot was given agitated come-on signals, a low close to the ramp, immediately followed by a wave-off. He appeared to take off some power and then add full throttle. The hook caught number 3 wire.
