GRAMPAW PETTIBONE

High and Dry

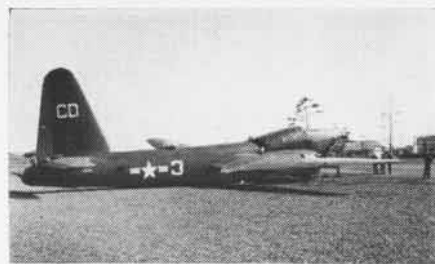
This P2V with a broken back wasn't damaged in flight, or while taxiing, or while being towed. The \$1,000,000 loss occurred while it was parked.

Shortly after the pilot started the starboard engine, the main landing gear retracted. Pilot, co-pilot, and plane captain state that the landing gear handle was in the "down" position. However, the landing gear locking pins—stiff knees—had been removed before full hydraulic pressure had been obtained.

In the case of the plane pictured above, the main oleo seals had been replaced by the local FASRon detachment with the help of two members of the flight crew. To facilitate this operation, the landing gear selector valve was manually held in the "up" position for over thirty minutes while the oleo seals were being replaced. When the work was completed, the gear was locked in the down position by gravity alone. Hydraulic pressure was not used.

Inspection after the accident indicated that the landing gear selector valve seals were swollen and torn and a deposit of soft foreign matter was found in the unit. Considering the above, it is probable that the selector valve stuck in the "up" position, even though the gear handle was in the "down" position.

Since it is impossible to remove the stiff knees if the system pressure is applied to the "up" side of the landing gear actuating cylinder, they should be removed only after full hydraulic pressure has been obtained.

Had the landing gear been drop checked after the work was completed, these discrepancies probably would have been discovered, but this was not done.

Finally, had the stiff knees been left in position until after full hydraulic pressure was obtained, it would have been impossible to remove them with the selector valve stuck in the "up" position.
