GRAMPAW PETTIBONE

Lame Duck

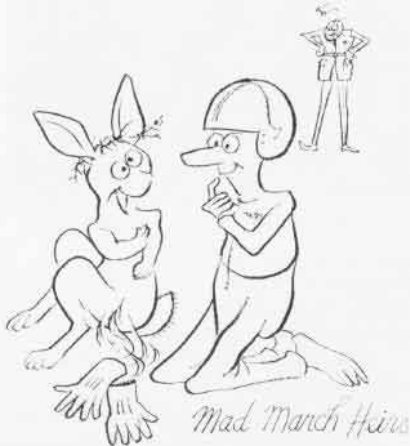
A flight of A-4C's landed at a West Coast NAS. One of the pilots had directional control problems during landing rollout because the starboard main gear shock strut remained fully extended. He shut down on the runway and the aircraft was towed to the servicing area without mishap.

The flight back was uneventful, but as he came in to land, he realized the starboard strut was fully extended when the aircraft swerved to port and a waveoff was executed. During take-off roll, the starboard wheel struck the midfield arresting gear chain damaging the wheel and brake assembly. With a fuel state of 1800 pounds, the pilot requested that the midfield gear be rigged and was advised there would be a five-minute delay. Ap-

On the second pass, the hook engaged the gear on runway heading and about 10 feet to the left of centerline. The aircraft swerved across the unpaid out chain, shearing the port main gear and stopped 15 feet off the runway.

Disassembly of the starboard strut revealed it contained only one quart

of hydraulic fluid instead of four quarts as required by the Handbook of Maintenance Instructions (HMI). In addition, the air pressure with the strut fully extended was 200 psi vice a recommended pressure of 25 psi.

The HMI is pretty clear on just how to service these shock struts and the A-4 NATOPS clearly states: "If at any time prior to landing, it is known that a directional control problem exists or a minimum roll-out is desired, a short field arrestment should be made and assistance of an LSO requested."

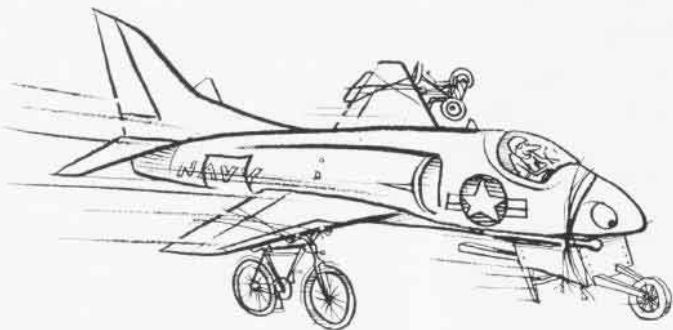
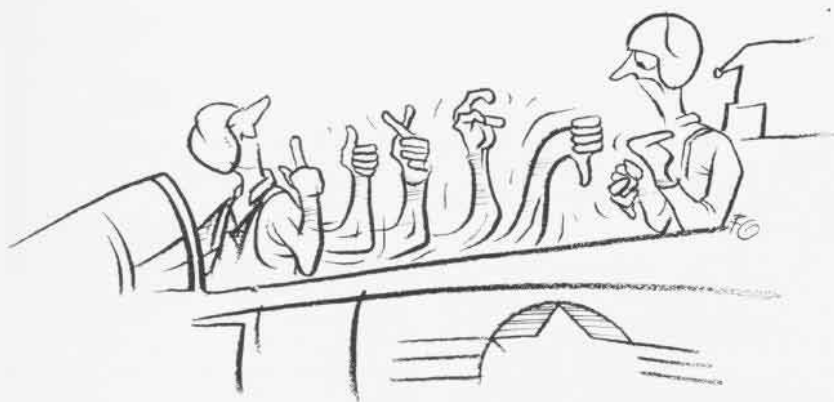
the engine to accelerate to idle RPM, he informed the RIO of the progress of the test. After both engines were operating normally, the pilot switched the main generators back on. As he did so, the ICS, radio, AJB-3, and gear and flap indicators failed. The pilot immediately checked the operating instruments and determined that no immediate danger existed.

Knowing that the RIO would be concerned about the electrical failure, the pilot looked in the mirror and saw the RIO looking forward. He gave him a "thumbs up" signal with the left hand to indicate the situation was under control. The RIO returned the "thumbs up" signal which the pilot acknowledged by nodding his head. The pilot was watching the RIO in the mirror. Just after nodding his head, the pilot saw the RIO position himself for ejection and reach for the curtain!

The pilot was unable to regain the RIO's attention. The RIO ejected at 8000 feet, 250 knots. The pilot did not see the RIO after he ejected and, as his radio was inoperative, he returned to base for landing and alerted SAR.

This should be warnin' enough for you pilots and RIO's to get your signals squared away once and for all.

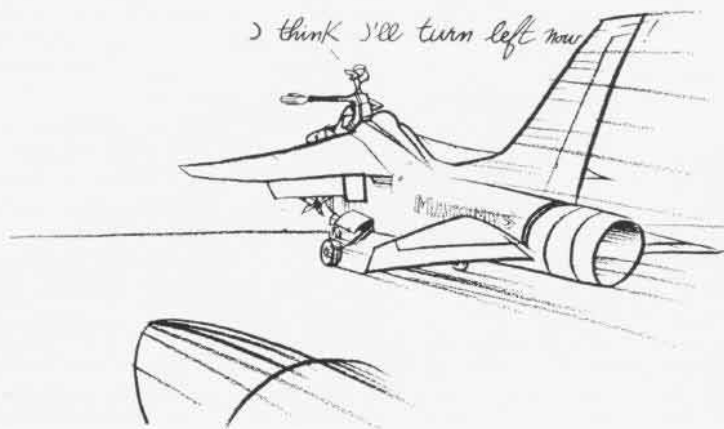
The wingman touched down on the left side of the runway a little fast and started braking at the 4000-foot marker. In less than 1000 feet, the starboard tire blew. Realizing the other aircraft was still on the runway, the pilot applied heavy port brake. As the wingman neared the end of the runway, he suddenly saw his leader turn in front of him. He immediately applied right brake in an effort to pass behind him. Instead, the nose and port wing caught the tail assembly of the other F-8 and spun it around 180 degrees. Both aircraft were substantially damaged, but luckily neither pilot was injured.

This flight leader elected not to use the Morest gear even though it was squadron doctrine on a wet runway, failed to follow tower instructions in order to clear the runway safely, and then to really cap things off turned in front of his wingman rolling out behind him. I'll admit a lot of things have changed in the flyin' business the past few years, but tricks like this have been TABOO since the days of the open cockpit and streaming white scarf.
