GRAMPAW PETTIBONE

Hacked Hawk

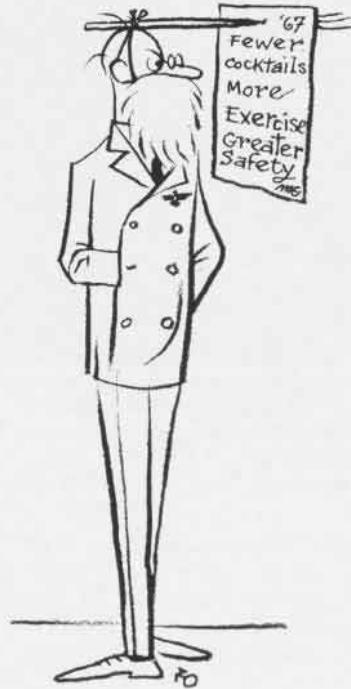
maybe a prayer will do it!

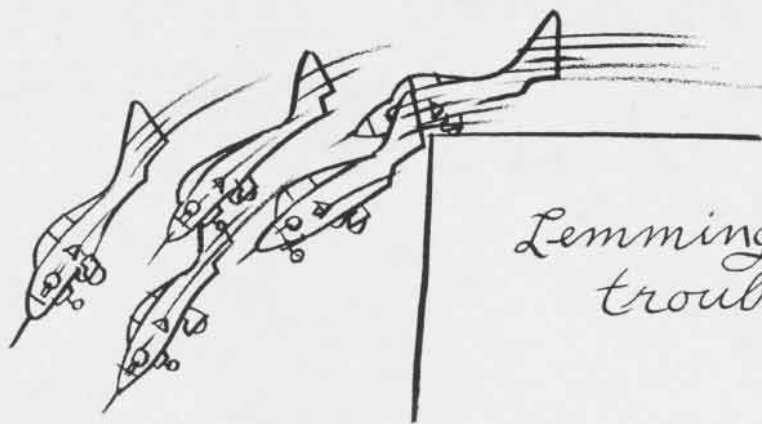
Lemming trouble!
