GRAMPAW PETTIBONE

Splashdown

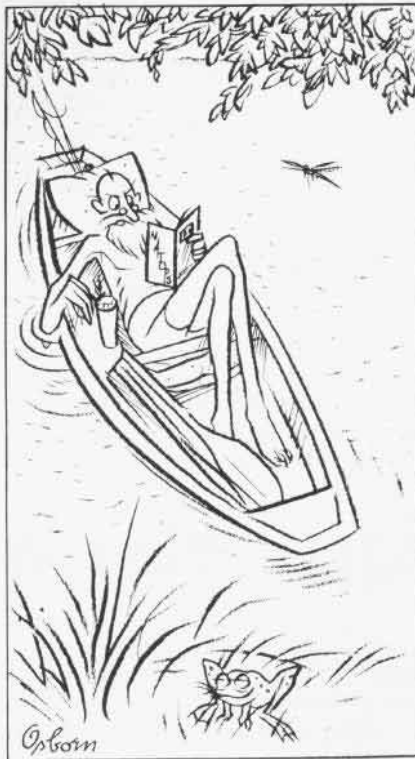
The aircraft hit the water, wings level, slightly nose high, approximately 1,000 yards from the approach end of the runway. It stayed partially

Sufferin' catfish! I don't believe it! This one really has my dander up! Know why the engines failed? The water injection system had been serviced with a mixture of water injection and dry cleaning fluids. Ain't that grand!

Look at the circumstances of this fiasco: Drums of dry cleaning fluid delivered instead of the alcohol ordered. Signed for by a supply petty officer who didn't check. Placed in a dark area where alcohol is normally stored, again without checking. Later used to service the aircraft — you're right — without checking.

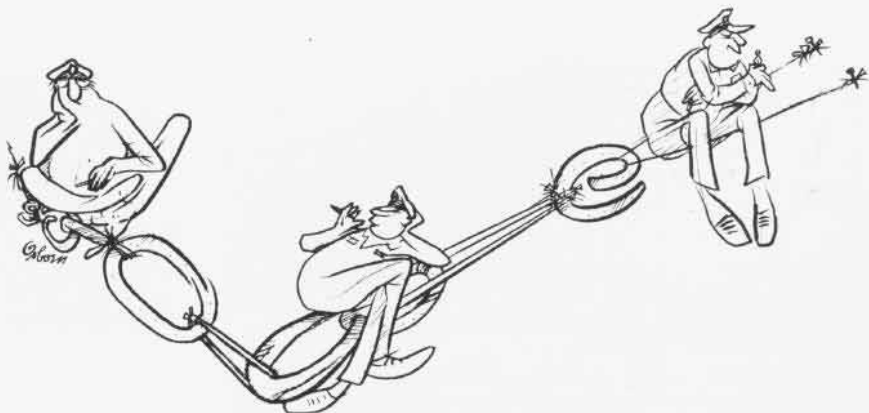
The two crew members and the passenger sustained minor injuries but the pilots were uninjured. With a flashlight, they inspected the helo and found that the entire tail pylon section, from the hinge fold point aft, was missing. It was later found one-third of a mile from the point of impact.

Investigation showed structural failure of the tail pylon section and loss of all directional control. The section had separated from the aircraft in flight "due to progressive fatigue type

fractures in both hinge fitting assemblies on the left side of the fuselage."

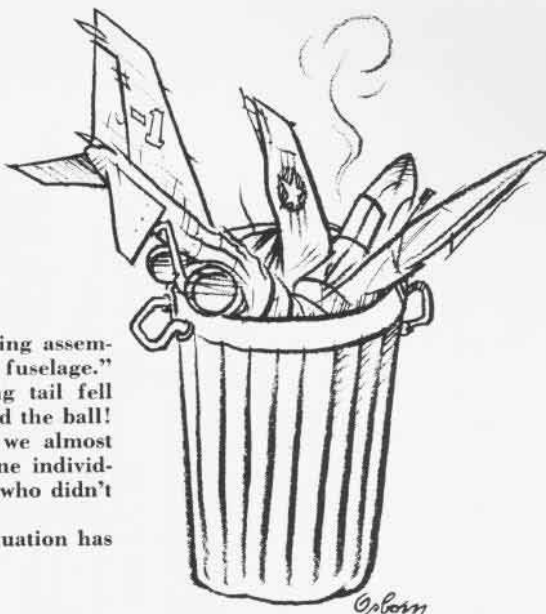
The empennage and both sides of the horizontal stabilator struck the flight deck edge, a guard rail stanchion piercing the empennage. The aircraft was suspended on its nose gear, left main mount and empennage, with the right main gear well clear of the elevator deck. (Five tie-down chains held, but one parted.)

Elevator four was hand-cranked back to flight deck level but the aircraft had already been substantially damaged.
