GRAMPAW PETTIBONE

Sea King – Sea Food

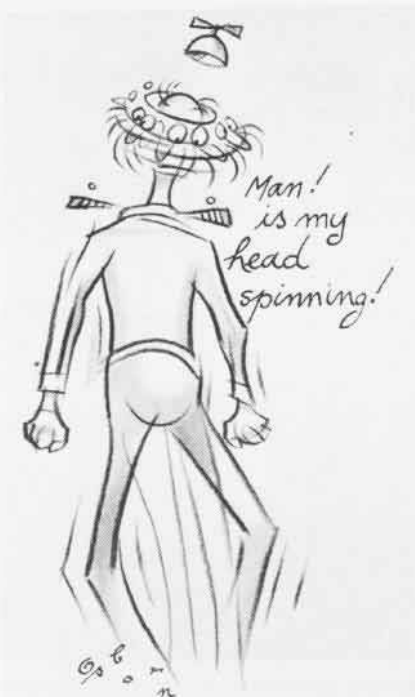
After one hour of flight, 1,000 pounds of fuel had been consumed. Ten minutes later, however, the fuel gauges showed 2,000 pounds of fuel depleted. A crew member reported that he smelled fumes and the HAC ordered a search for leaks. Looking out the cargo hatch, a crewman observed fuel streaming from the tail of the aircraft. Seconds later, the #1 engine flamed out. The HAC again took control of the aircraft, transmitted an emergency call to the ship, and was cleared for an immediate landing. Several aircraft were spotted for launch on the CV fantail, forcing the HAC to plan for a run-on-landing on the angle, crossing the deck in the direction of #2 catapult. Passing the stern of the carrier, the SH-3 was at 150 feet, with air speed at 70-80 knots and rotor speed (NR) established at 98 percent. At one-quarter nm final,

the aircraft was at 100 feet, airspeed 70 knots, with NR at 90. Abeam the Fresnel lens, the helo had descended to flight deck level, airspeed now 50 knots with sink rate increasing. The pilot then executed a waveoff to the left. Now below flight deck level with sink rate continuing, the HAC instructed the copilot to dump fuel, jettison sonobuoys and bring on manual throttle. All efforts to regain NR and decrease sink rate were ineffective. Passing through 40 feet with NR at 85, the pilot flared the helo and slowed to 20 knots prior to hitting the water. Upon impact, the nose tucked and a large swell engulfed the aircraft's forward section. The helo rapidly rolled left and flipped inverted.

was attributed to material failure. Unfortunately, the exact cause cannot be determined since the aircraft was not recovered. It is suspected that failure of the starboard fuel filter assembly resulted in sufficient fuel flow interruption to cause engine flameout.

A contributing cause was listed as pilot error in that the HAC took physical control of the aircraft too hastily, attempted an immediate landing without exercising other options, and did not adequately establish maximum single-engine performance parameters. It was felt that the copilot had the aircraft safely under control and that the HAC should have involved himself more in developing a plan that would have conserved sufficient energy (i.e., dump fuel, sonobuoys, etc.) prior to attempting a left-seat, no-hover, roll-on landing. Some doubt exists as to the proper execution of the single-engine emergency checklist, since both the HAC and the copilot reached for the speed controls but each thought the other had or would move them. The copilot did not – the HAC couldn't remember. The SH-3 has rather decent single-engine qualities and does not demand extreme urgency in getting it on deck.

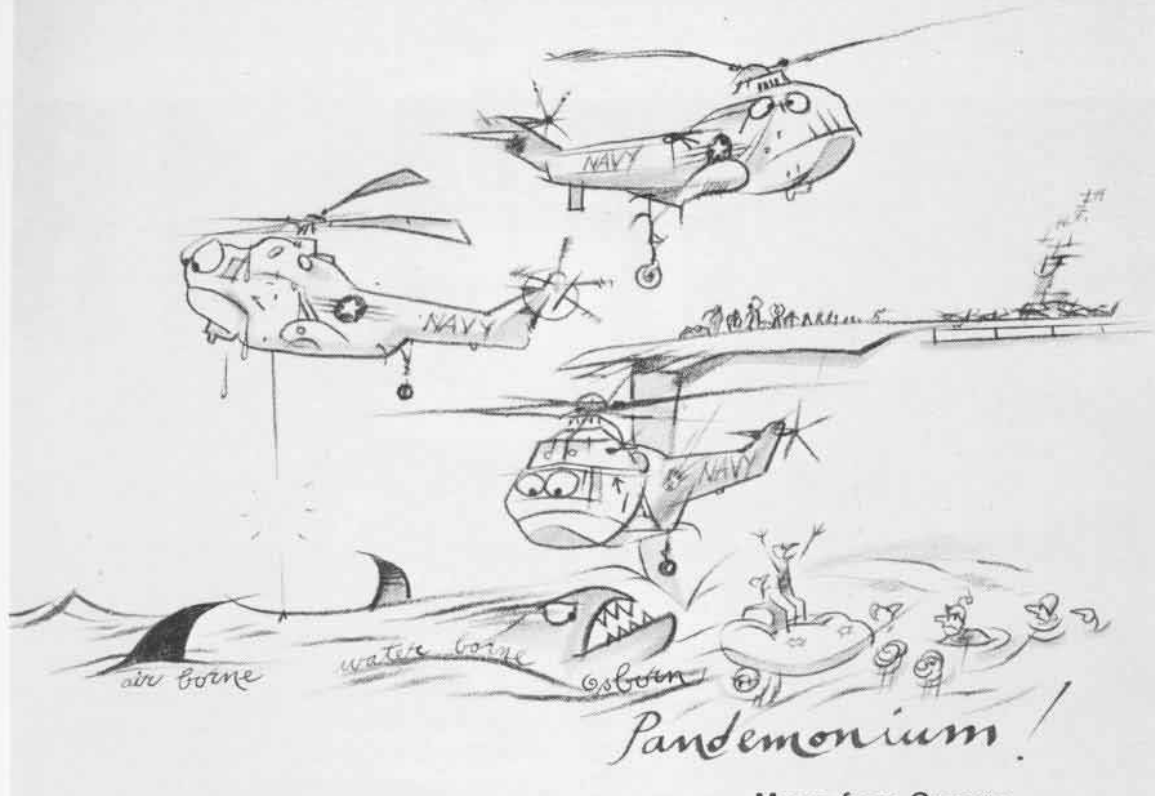
The rescue of this crew proved to be most interesting. A second SAR SH-3 hovered over the sinking helo as soon as the spray of the rotors striking the water subsided. No survivors were visible. Several seconds later, five crewmen appeared on the surface, three of whom were hoisted into the helo. A raft was lowered to the remaining two (copilot and passenger crewman) and the helo returned to the carrier for more fuel. While it was refueling, a third SH-3 was launched to retrieve the other two survivors. This helo was in a down status for SAR to replace

the rescue hoist cable with no hook attached. The crew effected a quick-splice attachment and checked it for slippage by suspending a heavyweight troubleshooter. SAR helo #3 flew beyond the passenger, who was in the raft, and began a hover to rescue the copilot. A wetcrewman entered the water to assist. The co-pilot and wetcrewman hooked up and were hoisted upward. As they reached the cargo door, the hoist cable separated, plunging the two back into the water, 20-25 feet. A raft was lowered from the helpless, hookless helo and the carrier was notified. SAR helo #2, now airborne following refueling, was hovering to rescue the passenger crewman on the raft when SAR helo #3 asked #2 to hurry as sharks had been spotted 50 yards away. They were heading toward their two unaware intended victims who were struggling to get into the raft. Helo #2 rescued the raft passenger and quickly air-taxied over to pick up the copilot and wetcrewman. The second of the two tumbled into the raft just as Old John Jaws made a lip-smacking pass by the raft. Sea King #2 retrieved the two and returned them to the carrier unharmed.
