8 Board and Counting

Bronco Belly Burner

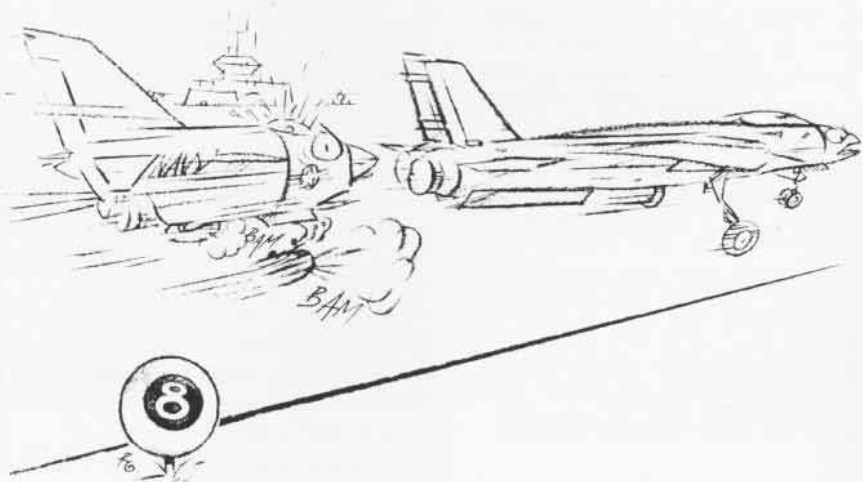
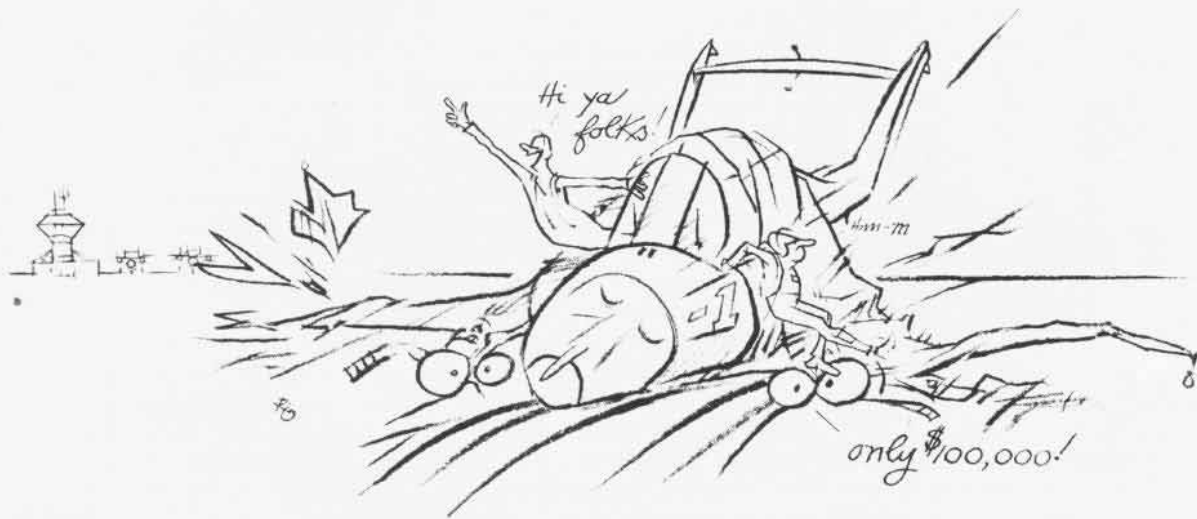
After passing the 8 board (8,000 feet remaining), both main tires blew. The aircraft was on centerline at the 7 board but began turning left in a right skid, completing a 160-degree ground loop on the runway's left shoulder. The starboard main gear collapsed as the aircraft came to a

stop, dropping the wing to the ground. Neither flyer was hurt.

My achin' acorns! Another judgment call that costs. Although reliable witnesses said the Phantom and Tomcat had proper interval, the pilot believed he was in extremis and began braking early. The F-4B/N NATOPS states that "Normally, wheel brakes should be used only below 100 knots since the probability of blowing a tire decreases significantly with a reduction in ground speed. . . . At high speed, brake pedal deflections as small as 1/16 inch have proved sufficient to blow a tire."

Postflight checks revealed no electrical continuity discrepancies in the nose gear steering system, yet the Phantom went out of control as it slowed down. Could be the pilot thought the worst was over and relaxed his vigil.

have to say it again: Know your machine. Stay ahead of it. And remember, a pilot is often like a quarterback dropping back into the pocket lookin' for a receiver while six huge linemen are bearin' down on him. Quick and correct decisions are a must for safety and health.
