GRAMPAW PETTIBONE

Hacked Hawk

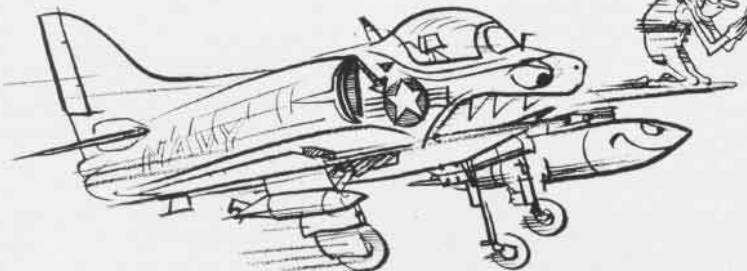
maybe a prayer will do it!

Jumpin' Jehosophat! This young fella could have saved himself a lot of grief by readin' page 24 of the NATOPS Pocket Check List and just using a little common sense. Maximum asymmetrical load for landing and takeoff is 1,200 pounds in this *Hawk* and everybody else knows you find it a lot easier to put the heavy wing into the crosswind.

The price of that tank is around \$1,800 and the cost to repair Charlie damage is approximately \$18,000. Simple arithmetic shows it's a lot better to use standardized procedures than to rely on luck and superstition.
