NAVAL AVIATION

Midway Shakedown  
FIDO • Maintenance

February 1946

U.S.S. MIDWAY, FIRST OF THE CVB'S, SHAKES DOWN IN CARIBBEAN

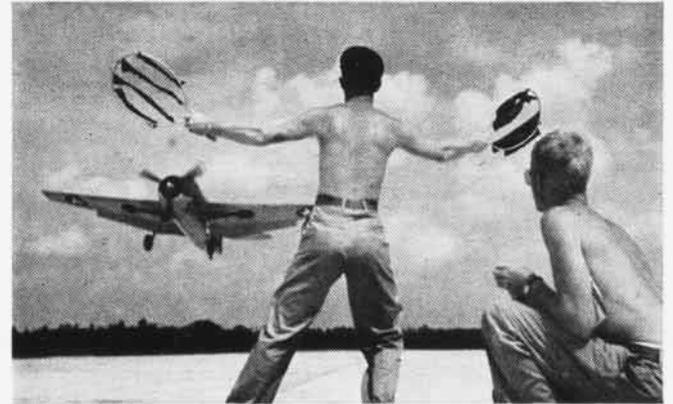
Pilots and flight deck crews train for carrier work on "field" carrier decks, complete with landing wires, barriers and an LSO

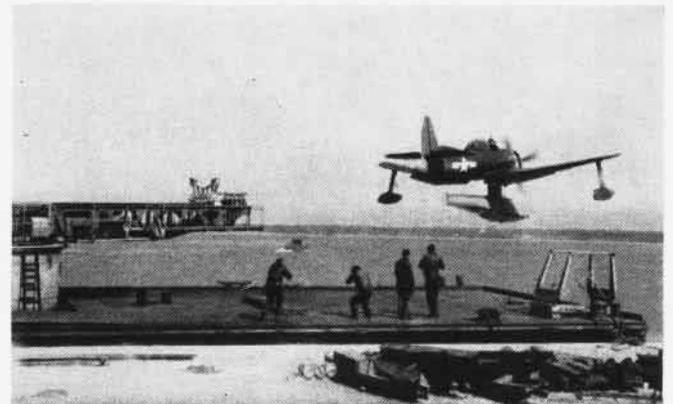
Shorebound catapults like the one at NATC PATUXENT RIVER, give catapult men as well as pilots an opportunity to learn principles

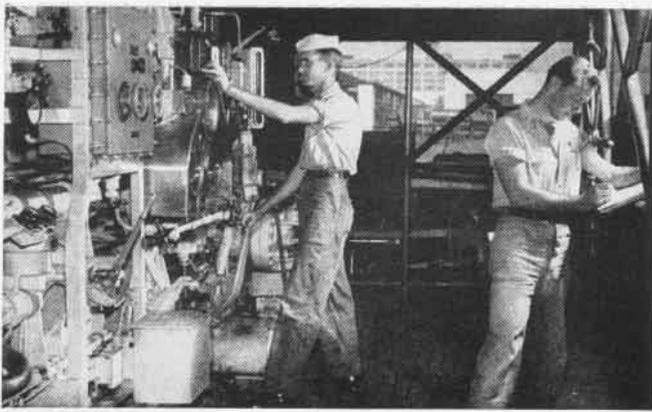
Catapult detail students work at the controls of a complete installation at the Naval Air Experimental Station in Philadelphia

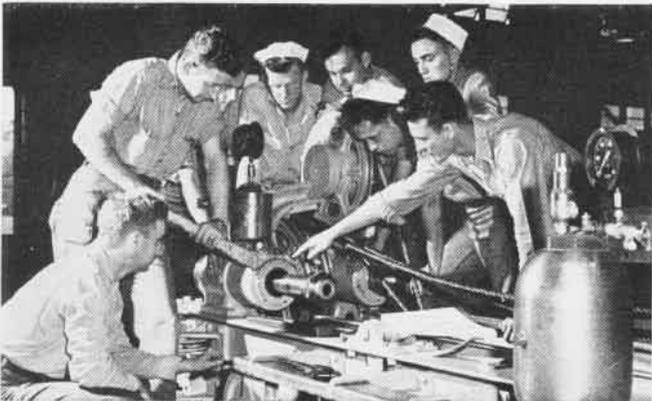
All details of the II-2 catapult, used on CVEs and CVLs are studied carefully in pre-shakedown school. Students discuss buffer

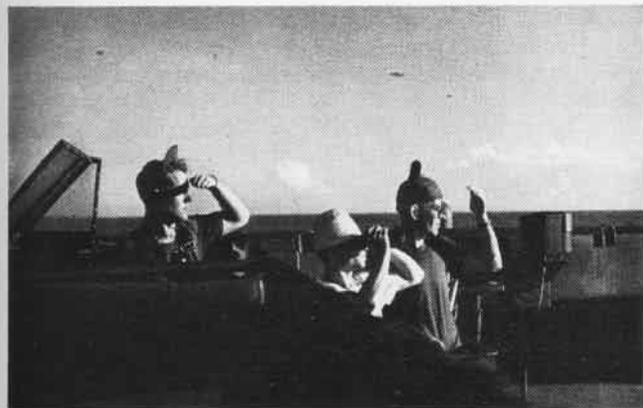
LSO's eyes, ears and voice: talker communicates with the bridge; hookman checks incoming planes; deckman checks for obstacles

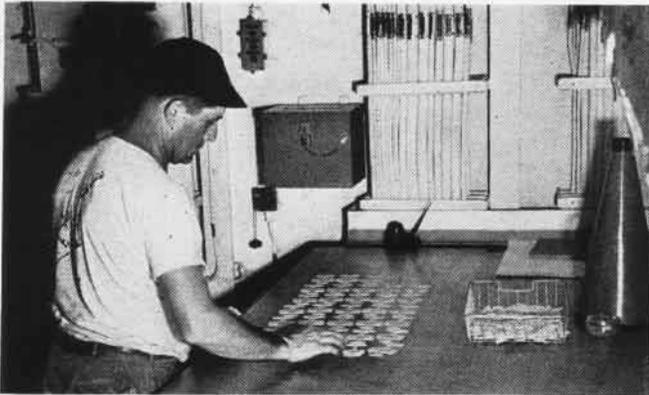
**Flight deck** officer plans his deck spotting with plastic planes on a deck diagram board in the flight deck office before operations

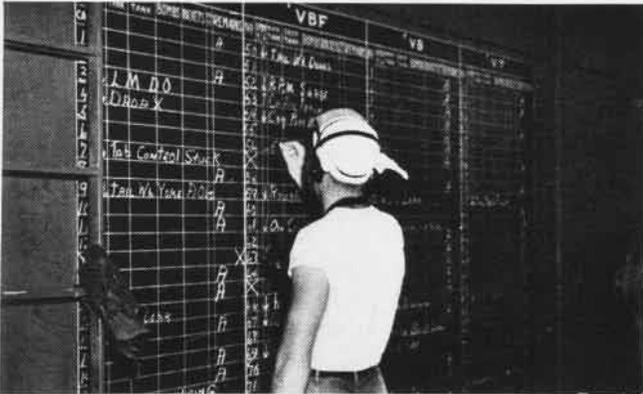
**Status control** board on the flight deck tabulates all troubles; information is relayed to Air Plot, Flight Deck Control, and V-2

Biggest V-2 problem usually is that of keeping up with, and keeping track of aircraft needing repairs—"status control". The *Midway's* crew faced a prodigious job in this respect, with 121 planes to care for, and huge spaces of flight and hangar decks for planes to get lost on. One plane with a minor hydraulic leak might easily slip by unnoticed, with disastrous results. The *Midway's* V-2 outfit solved the problem, however, by using the ship's sound-powered telephone system. The hangar deck chief, with phone hooked to his belt ready to plug into the system at any one of the hundreds of outlets on board, checked each plane coming in, noted necessary repairs, and by plugging in was able instantly to notify Air Plot, Flight Deck Control, and the V-2 office. The plane was unmistakably earmarked.

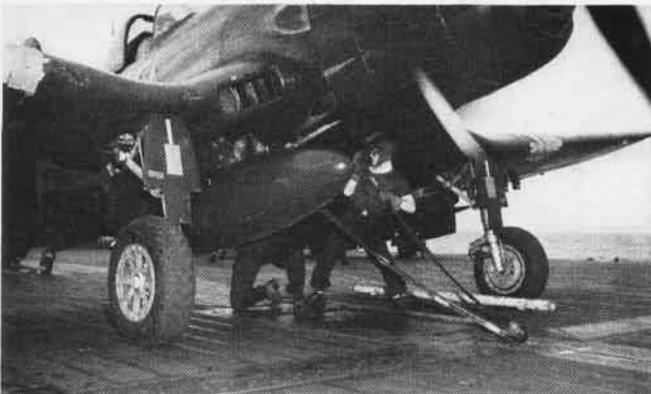
**Pre-shakedown** training is put to the test on board ship. Here a *Midway* catapult crew fixes bridle to plane about to be launched

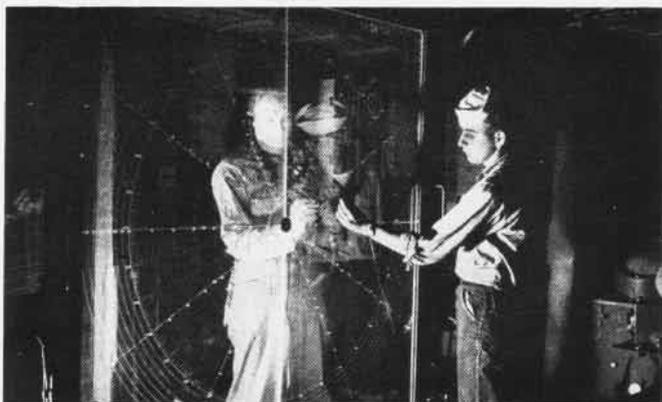
**Jack-o'-lantern** lighting characterizes *Midway's* large CIC room, where these men are plotting a problem on luminous plot board

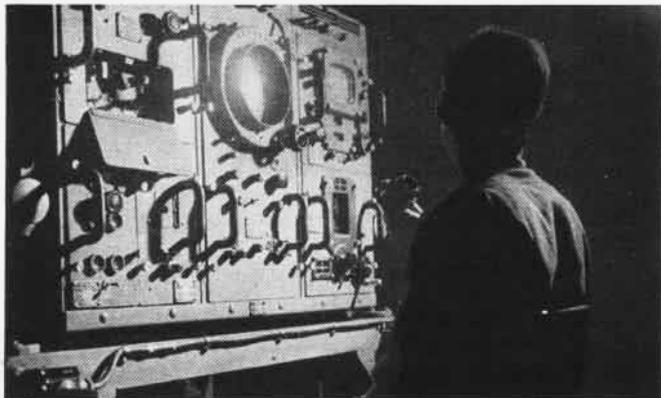
**Surface** search is watched constantly on this radar set in the CIC room. Twenty-four-hour watch was maintained all during cruise

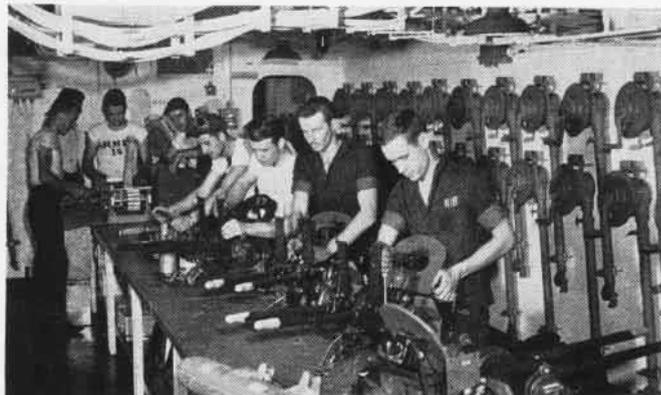
**Arming crews** prepare wing guns for a strafing operation. At far end of bench, machine gun belts are being loaded on special gear

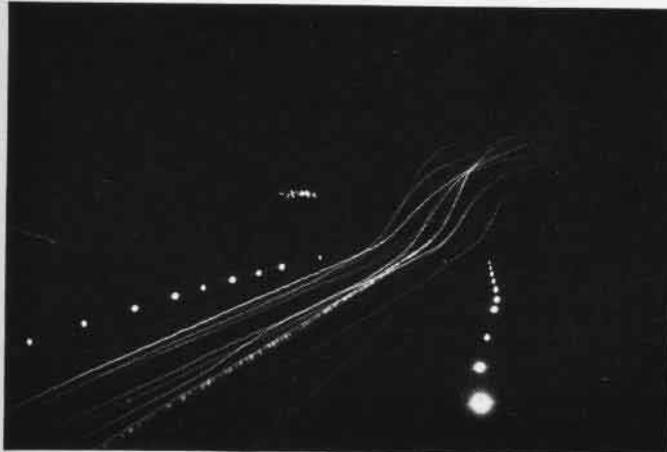
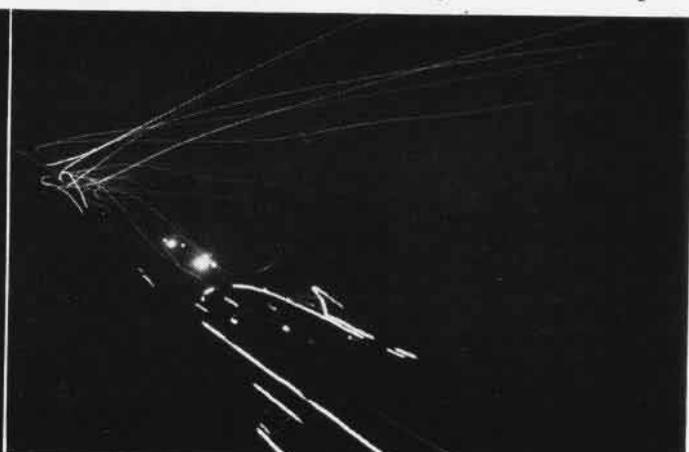
**Night operations.** Camera set up to record faults of pilots that will be discussed later in ready rooms, show take-offs (below, left). Egg shapes are deck lights. Lights off port are destroyer's. Solid streaks are wing and tail lights; jagged lines, exhaust. Note one droopy take-off to starboard. Below, right, is the landing pattern

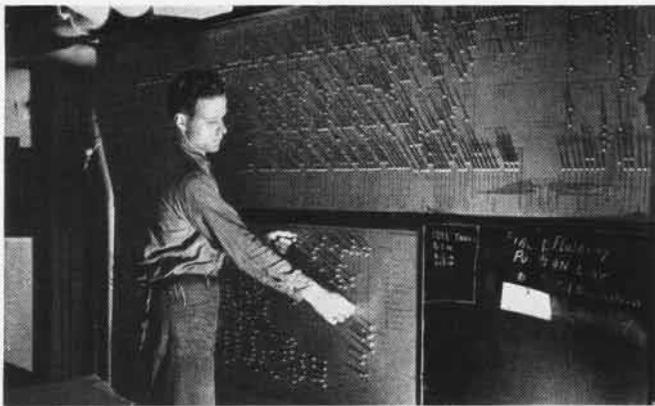
Damage control is simplified on *Midway* by board showing all systems on ship, with tiny valve handles for each real one aboard

In the damage control office huge boards show entire systems of pipes and valves for the ship. A magazine board lights up when ammo compartment temperatures rise too high. In a few seconds, the compartment can be flooded by referring to the master board and calling the watch on the proper valve station, via sound-powered telephone.

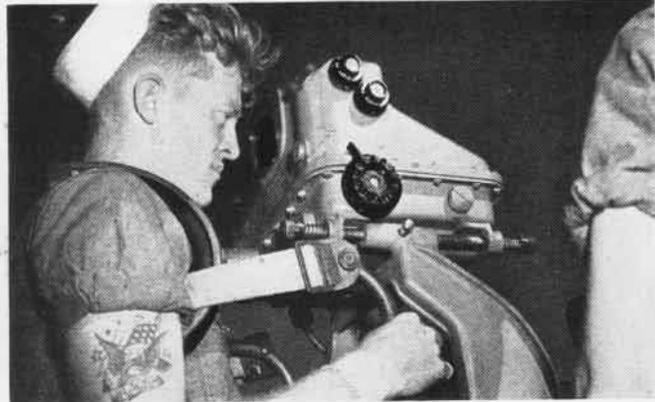
*Midway's* quadruplicate 40's are controlled by individual directors like this one. In this case it happens to be a Mk 51 director

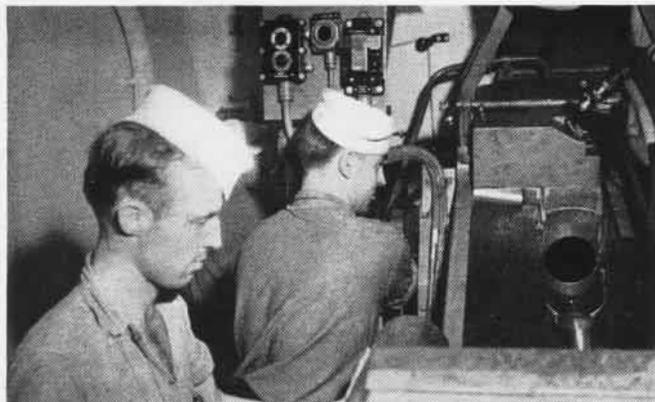
Inside the big five-inch gun turrets there's plenty of space, and much less noise than on the deck. Note breech in the foreground

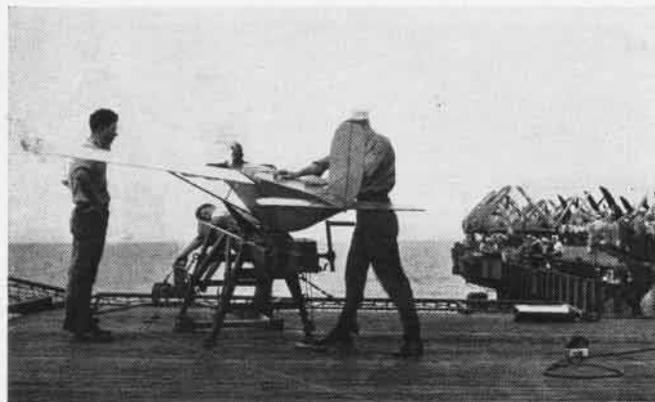
For antiaircraft gunnery, the *Midway* carried her own TDD unit, with crew and 15 drones. Drones were catapulted from the deck

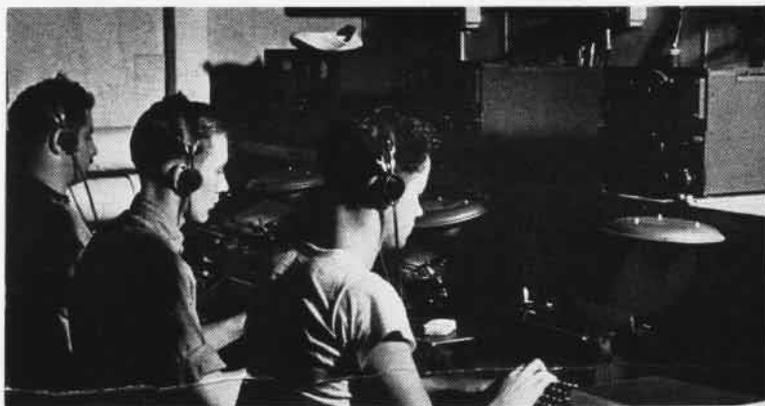
During strike on Culebra Island, radio monitors guard all frequencies that have been previously established for the attack problem.

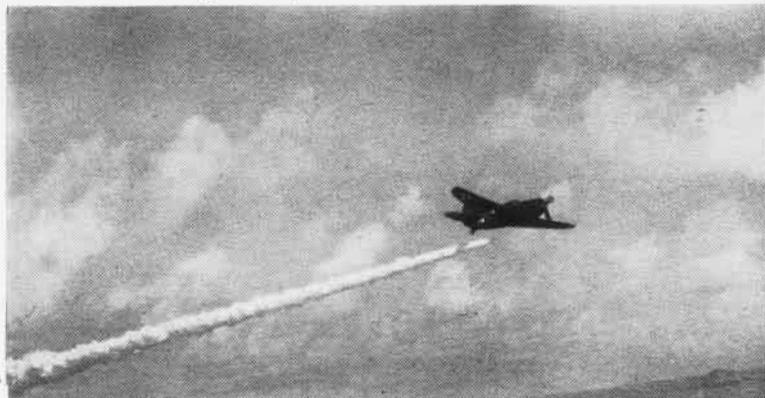
Culebra strike includes everything that would happen on a regular wartime combat mission, including laying down of smoke screen

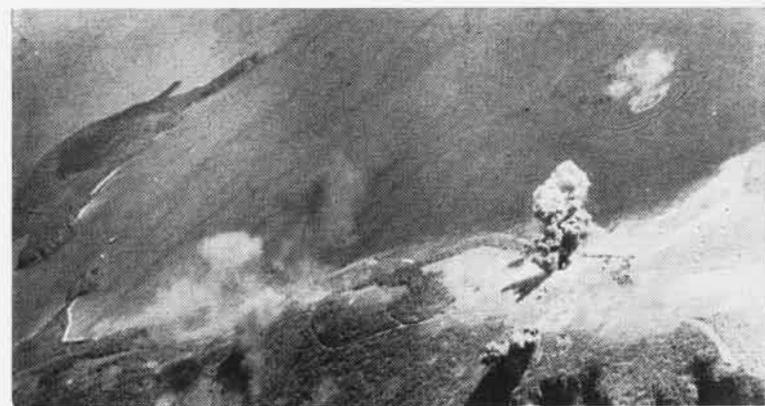
Live bombs are dropped on the two-and-a-half-square-mile target area; photo planes record effectiveness. Note pillboxes on target

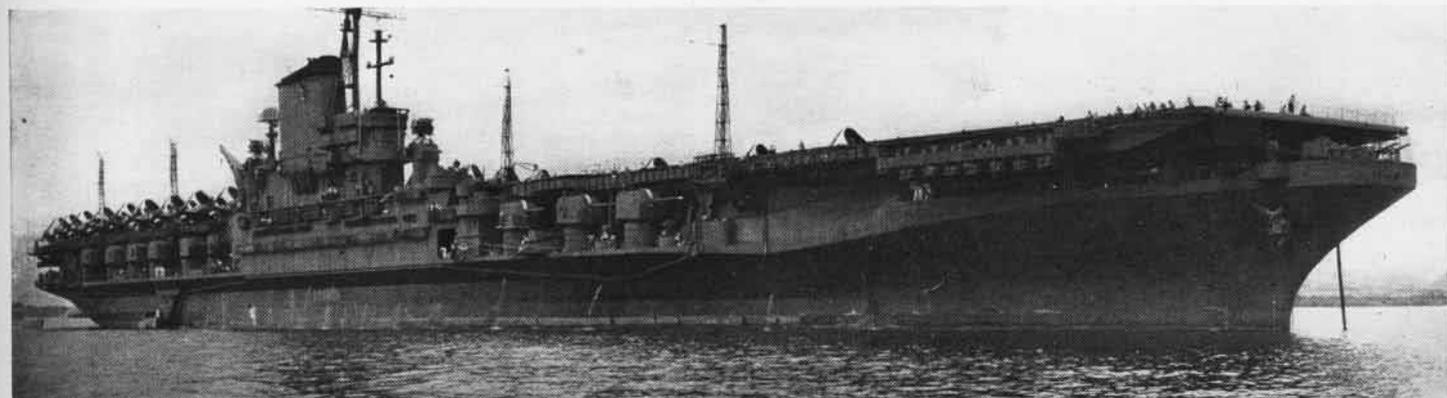
The *Midway's* huge size is more apparent in this outboard picture taken while ship was anchored in Guantanamo Bay, Cuba. Note

how, unlike CVs, five-inch gun turrets have been moved off flight deck to sponsons, and how island itself is set off on huge sponson

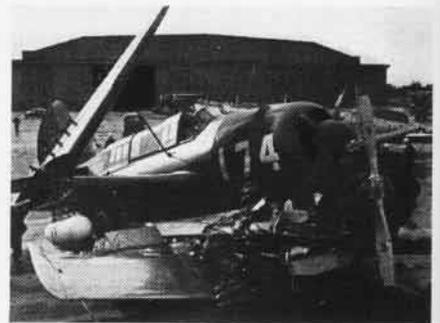
The engine of an SB2C suddenly roared into life. Tie down lines parted and the plane jumped its chocks, heading directly toward a row of parked planes. The picture shows the results. Cause: The inexperienced plane captain who was in the cockpit and who had started the engine for warm-up was

unfamiliar with correct starting procedure and was not on the ball! After the plane jumped the chocks it ran amuck for approximately 30 yards before crashing into an SNJ. Brakes were not applied, throttle was not cut nor was the ignition switch touched until after the crash.

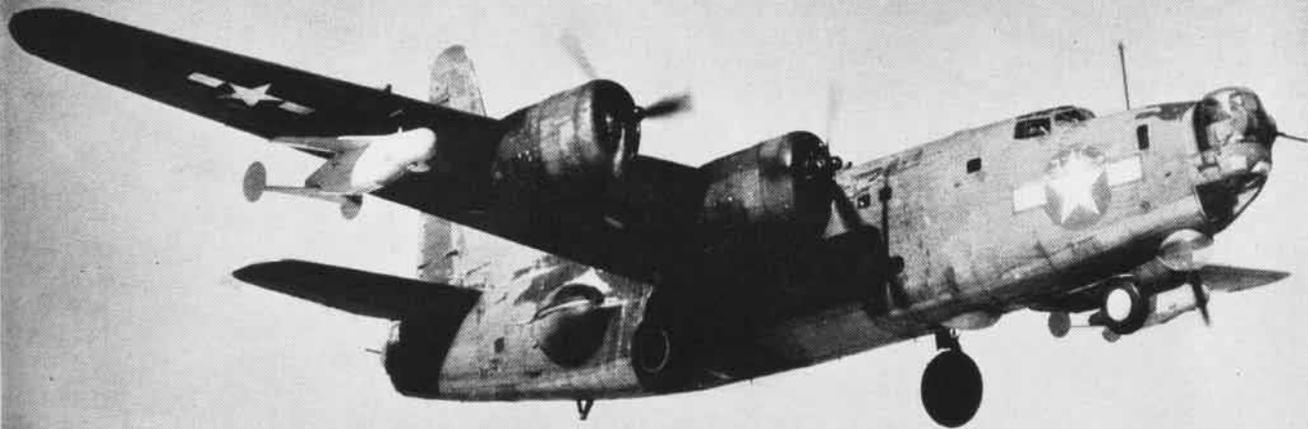
PRIVATEER CARRIERS ONE 12-FOOT-LONG BAT SUSPENDED UNDER EACH WING; BATS HAVE 10-FOOT WING SPAN. HOME AUTOMATICALLY

The *Bat* does not restrict flight operations of the parent plane nor does it appreciably affect flight characteristics. The launching plane's effectiveness with rockets, cannon or machine guns is not altered by having *Bats* attached.

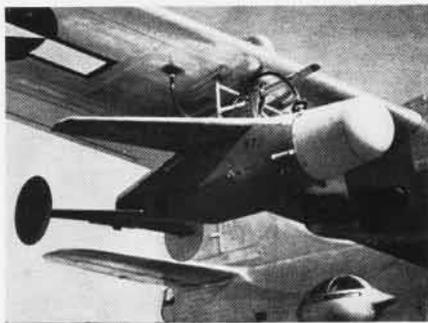
STANDARD BOMB RELEASE UNIT IS USED

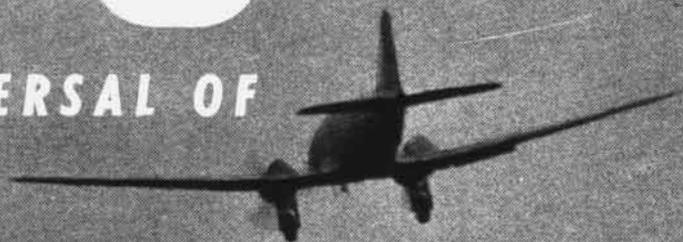
VISIBILITY WAS ZERO WHEN BURNERS STARTED TO OPERATE. TEN MINUTES OF HEAT CLEARED THE FIELD FOR THIS R4D LANDING

A typical FIDO test flight report shows the results being obtained at the experiment station. When the burners were ignited, the field had zero visibility and zero ceiling. Five minutes after ignition there was a ceiling of 1000 feet near the center of the runway with visibility quite good the full length of the installation. The plane, a PB4-1, took off from a cleared runway, but as soon as the last burner was passed it entered a zero-zero bank of heavy fog. The fog was topped at 2700 feet over the ocean and gradually raised to 3500 feet over the land. FIDO burned a hole through that! Landing was accomplished with use of the radio range station and SCS-51 approach gear, the runway becoming clearly visible at one-half mile and 100 feet. However, the ground could be seen from 150 feet and approximately one mile from the runway. This clearing was due entirely to the FIDO operation, as the surrounding area was still zero-zero visibility and ceiling.

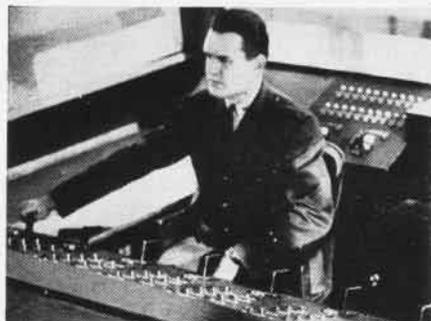
CENTRAL CONTROL OPERATES ALL BURNERS

stallations has been arranged so that an operator in the control tower can press a few buttons and electrically ignite more than 2000 feet of burners, lining the runways with banks of flame. At the same time experts are at their positions on the field gathering data on the experiments. The type of fog, size of its particles, dew point, temperature, temperature of the ocean water, wind velocity, and barometric pressure are all recorded. From the control tower an amplifier allows the officers in charge to speak to any of the men on the field. Walkie-talkies also are used.

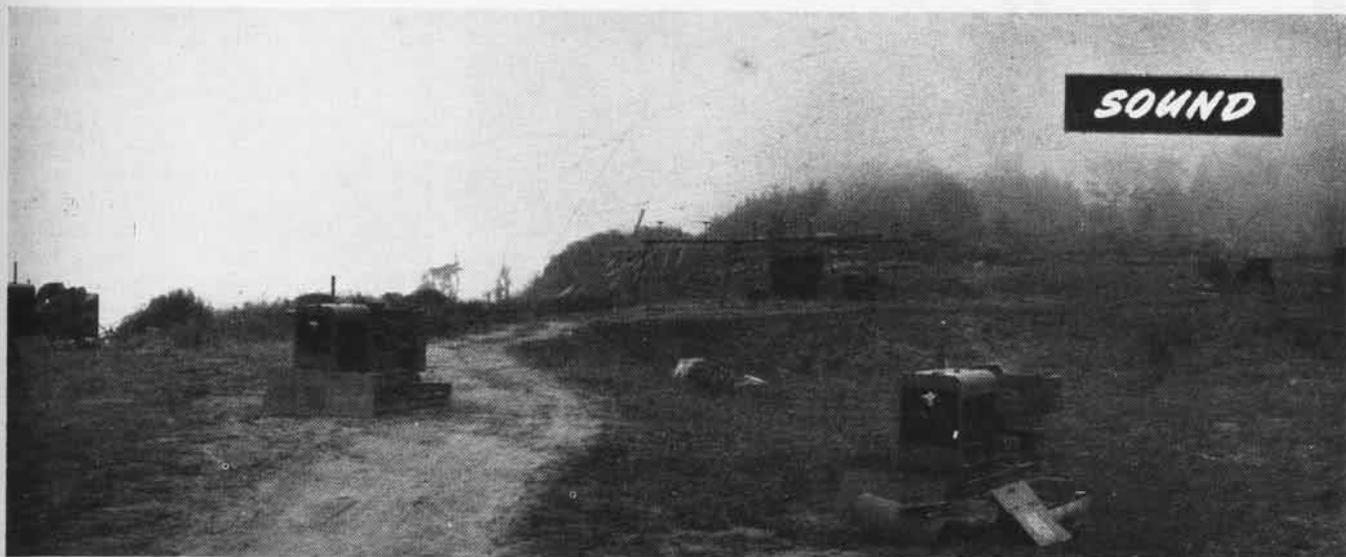
EAR PLUGS ARE NEEDED AS CLEARING IS ACCOMPLISHED BY SIRENS. HIGH FREQUENCY SOUND WAVES EXPECTED TO CUT THE DIN

**A**MONG the non-thermal systems being tried out, the sonic method has created a good deal of interest. It is based on the principle of changing fog to rain by high-frequency sound wave bombardment. Sound waves bounce the fog particles around, causing them to meet and merge, thus forming units large enough for precipitation as rain drops. The equipment consists of 12 powerful air raid-type sirens with 24-foot wooden horns to direct the sound. Local scuttlebutt has it that farmers in the neighborhood are worried about the effect of the sound bombardment on temperamental flocks of turkeys, but so far the Navy has received no complaints of feathered casualties. Sound wave fog dispersal, if it can be effected with more easily portable apparatus, has possibilities for aiding carrier aircraft. Investigations underway may lead to developments which will allow carriers operating in fog-bound waters to improve their own weather conditions.

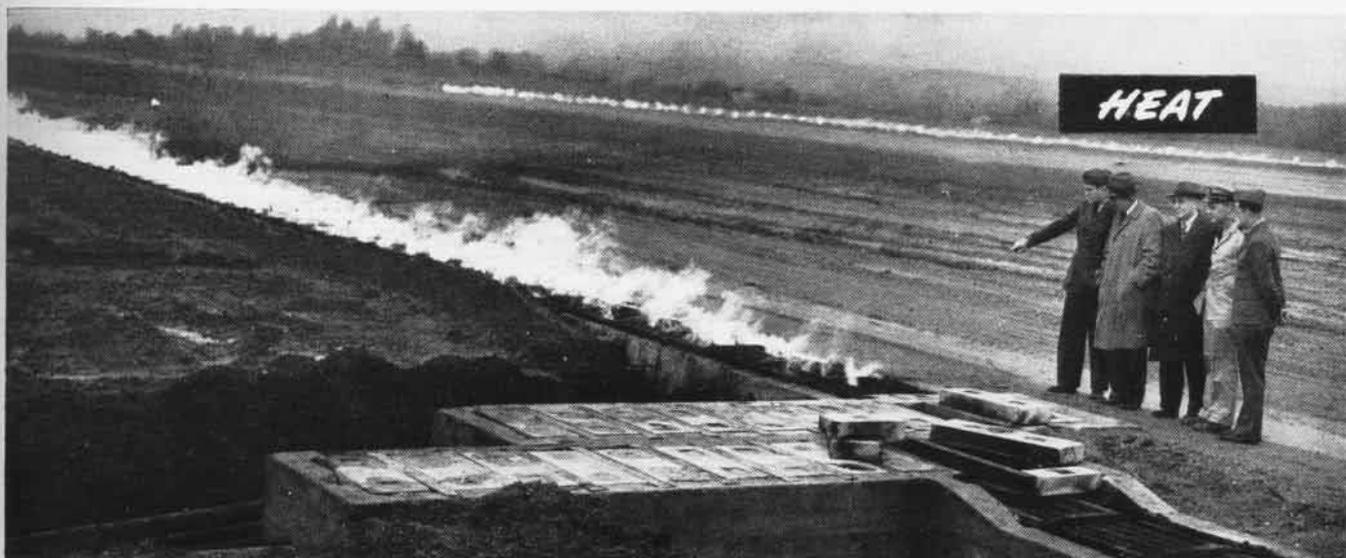
DIFFERENT TYPE BURNERS TESTED AT ARCATA FOR CHEAP, EFFECTIVE CLEARANCE. DIESEL FUEL UNDER HIGH PRESSURE CUTS COST

The most promising improvements being worked out to cut costs and increase efficiency are along the lines of atomizing fuel by high pressure rather than by heat. This method involves no smoke and no waste and can be operated with gasoline, kerosene, or diesel oil. Various types of burners developed for the cheaper fuels by the National Development and Research Committee, the British Petroleum Warfare Department, and other agencies are being tested.

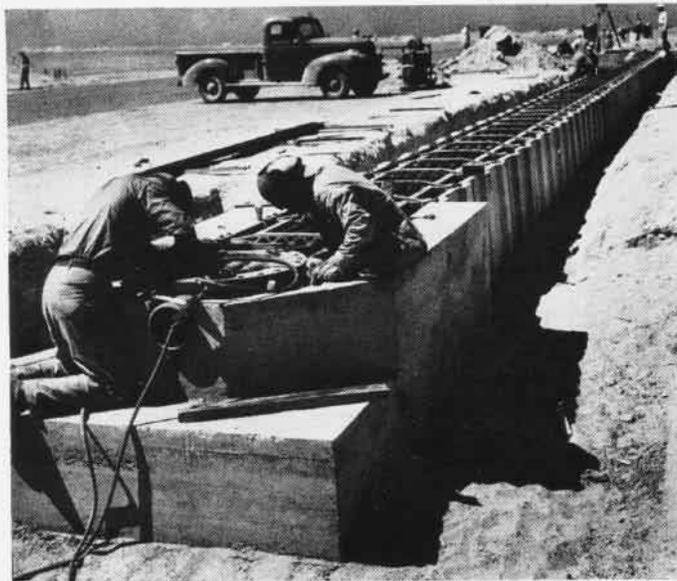
Assembling collecting pot on Hades-Rapex (Mk 3) installation; Fuel from 16 vaporizing tubes feeds into 8-inch burner pipe

The Hades-Rapex (USN Mk-3) burner has 16 vaporizing tubes feeding into a collecting pot. From the collecting pot the gasoline vapor under intense pressure is fed into a single eight-inch burner pipe which, when ignited, throws off an extremely high temperature.

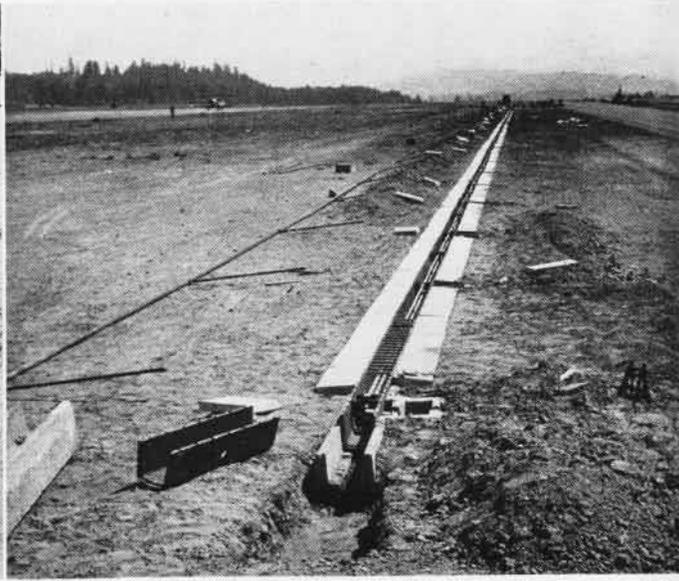
Slot Burner (Mk 5) gives 10 minute burn on 2500 gallons gas; British now use this type burner commercially at Heathrow field

The "slot" (USN Mk-5) burner consists of two one-inch pipes, one immediately above the other a few inches apart. Gasoline feeds through the top and at the end of the line makes a U-turn back into the bottom pipe. The lower pipe is drilled with regularly spaced holes through which gasoline feeds out and burns. This heats the gasoline above until it becomes a vapor and creates pressure. In a few minutes enough pressure is produced to shoot flames about the height of a man. Fuel consumption for 10 minutes operation is 2500 gallons of 60 octane gasoline at a cost of 6.7c per gallon.

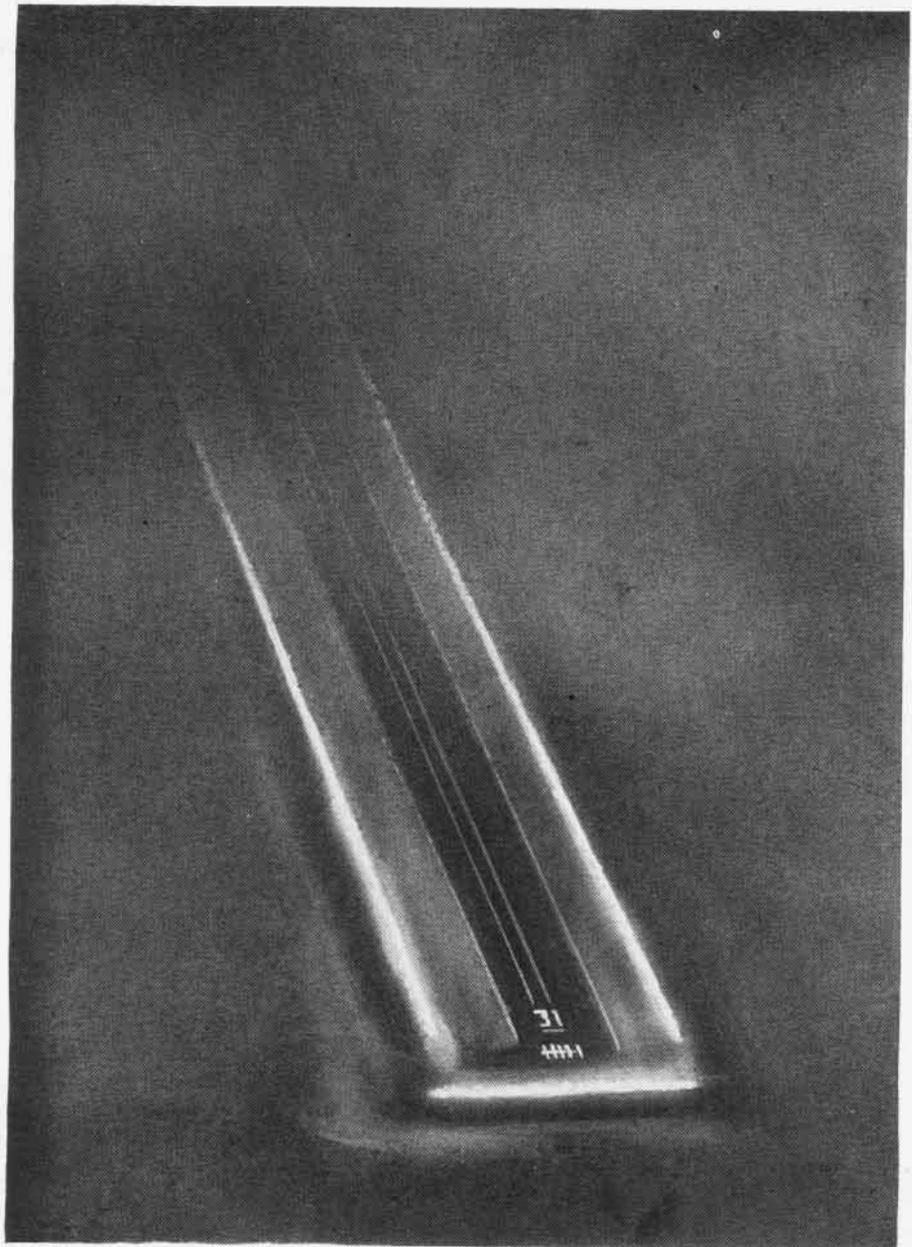
HOME FIRES BURNING THROUGH FOG; EXPERIMENT RESULTS WILL AID ALL PILOTS

experiments, of course, is only a temporary victory achieved for the time needed and then lost again. Lest he become too cocky over his success, the elements immediately revert to their former arrangement, as witness these conditions reported in a test burn. At 0945 visibility was 1/16 mile, ceiling 50 feet, temperature 53° F, humidity 100 percent. The burners were started, and at 1015 the sky became visible through thin strata, with a variable ceiling of 800 feet. Visibility was good the entire length of the installation. An hour after the burn started the maximum surface temperature of 66° F was reached, and humidity had dropped to 66 percent. Large portions of the sky showed through the fog 1700 feet deep. Then the burners were turned off. About fifteen minutes later the ceil-

ing had lowered to 100 feet, the visibility had lowered from the full length of the installation to 1/8 mile, and the humidity had increased to 94 percent.

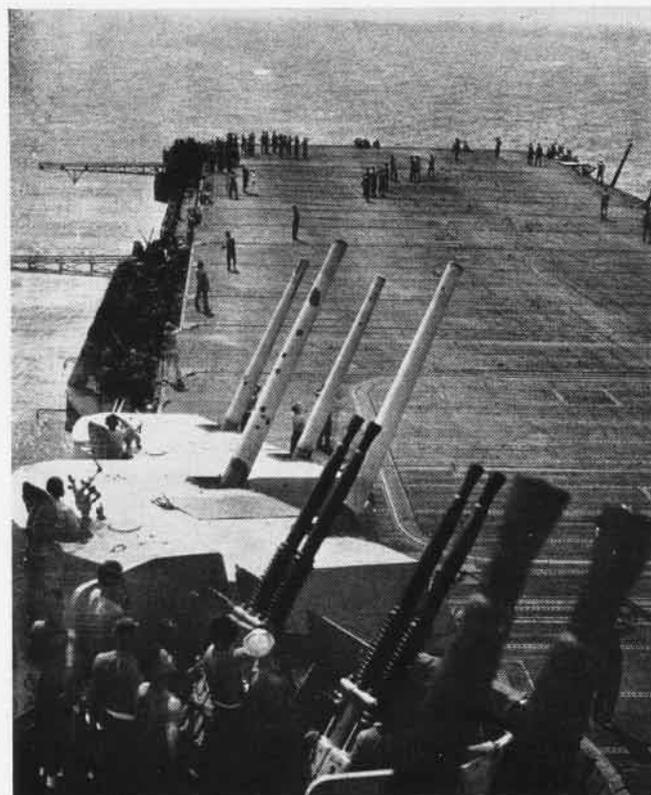
Anti-aircraft guns on *Essex* got tracking drill during lull while defending Okinawa action for 79 consecutive days without resting

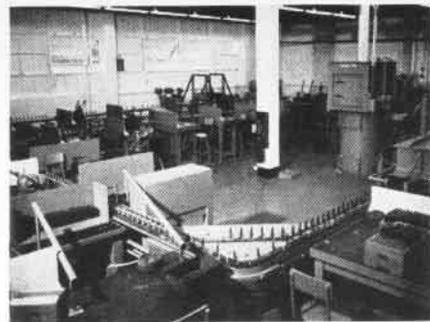
To increase the efficiency of new employees and quickly train any shifted personnel, visual aids are posted on the operational tables, showing the original position of the plug on the conveyor, transfer to the overhaul equipment, and replacement on the conveyor. These illustrations are drawn in a clear, concise, eye-catching manner so that the

SPARK PLUGS RIDE THE BELT AT NORFOLK

Spark plug overhaul time per plug has been cut in half at A&R, NAS NORFOLK, with a practical conveyORIZED system replacing the batch process. The new shop (see cut), planned for efficiency and speed in handling plugs, has proved highly successful. In the batch process each employee was given a tray of plugs which he overhauled from start to finish. In the conveyORIZED process each man is assigned to one specific operation in the sequence.

For overhaul the spark plugs are divided into two types: mica and ceramic, each group being processed on a separate conveyor. This division, combined with the variable speed provided for on the conveyors (one foot per second to two feet per second, chain speed), furnishes a very flexible production control, as conditions of personnel and work load demand. The spark plugs are carried along on spindles or spark plug holders, four such spindles in each foot of conveyor. This feature gives additional flexibility since the spindles can be loaded consecutively, alternately, or in any other pattern set up by the supervisor. The two roller chain conveyors with individual drives are elevated about 36 inches from the deck, and work tables of the same height parallel the line.

The following stages are set up in the operational sequence for ceramic plugs: 1. segregating, inspecting, and traying; 2. placing on conveyor; 3. degreasing; 4. sand blasting; 5. buffing of barrel; 6. buffing of thread; 7. cleaning of ceramic on barrel with rotating chamois, wet and dry; 8. die-chasing of barrel end and shell end; 9. gap setting and gas leak testing; 10. preliminary inspecting; 11. painting; 12. final inspecting and bomb testing; 13. applying rust preventive and copper gasket; 14. packaging in cardboard; 15. boxing.

A similar series of stages is arranged for mica plugs. Each operator on both the mica and ceramic production lines removes the plug, performs his work, and replaces the plug on the conveyor in a reverse position, from shell up to shell down. This reversing is important because it indicates that the previous operation has been completed or, in cases where two or more operators are working on one stage, that the current operation has been completed.

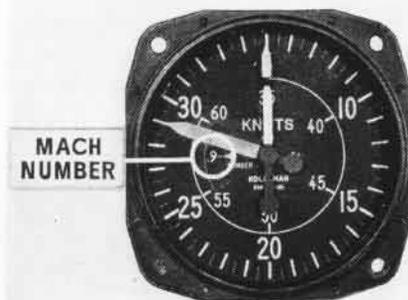
INDICATOR WARNS WHEN SPEED TOO HIGH

both the airspeed diaphragm and an added altitude diaphragm. The dial is calibrated in Mach number units from .3 to 1.0. This number is the ratio of true air speed to the local speed of sound. A modification of this indicator has been incorporated into the standard 50 to 600 knot airspeed indicator.

The instrument is essentially an airspeed indicator to which has been added a danger pointer responsive to

In the accompanying photograph, the Mach number setting is 0.9. Since the photograph was taken at approximately sea level conditions, the danger pointer rests at 590 knots indicated airspeed. Sea level maximum allowable indicated airspeed corresponding to a Mach number reading of 0.9 is 595 knots.

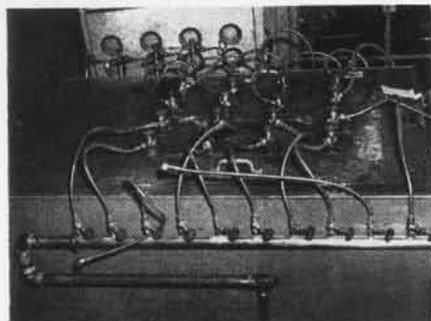
The suggested manifold is made of one-inch pipe having 20 valves, 10 on each side, threaded and silver soldered

FLEXIBLE ARMS ATTACH TO CYLINDERS

in place. Each valve is connected to a suitable length of flexible braided hose capable of withstanding the crushing load caused by vacuum. On the end of each hose is an adapter for easy attachment to the oxygen cylinder.

To overcome these disadvantages an improved manifold has been devised which facilitates drying since the manifold is flexible and is permanently attached outside the oven frame. Vacuum lines can be attached quickly and infrequent leaks are easily located. When a leak does occur, it can be isolated by closing the valve to the defective line, or when 16 cylinders are in the oven, by attaching one of the others already attached to the manifold.

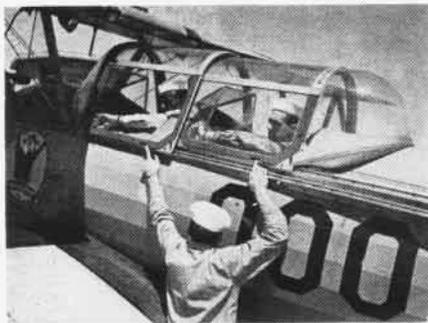
The handle is fastened to a metal strip which acts as a lock for a number of pins which secure the escape hatch retainer panel to the cockpit enclosure

INTERNAL AND EXTERNAL HATCH RELEASES

frame. Pushing the handle forward releases these pins and permits the plexiglas panel to be removed easily.

The hatch provides a means of removing quickly a panel in each of the sliding cockpit enclosures which will permit exit of the pilot and passenger. Exit is accomplished by a forward push on a handle conveniently located at the forward end of each escape hatch.

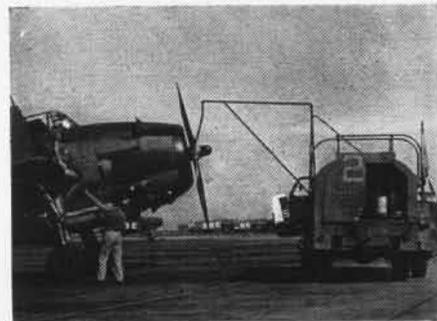
Use of this suggestion permits two men to refuel instead of three or four men. The truck driver passes the hose

REFUELING IS MADE EASY WITH NEW BOOM

nozzle to a man stationed on the plane wing who carries the hose over the cockpit greenhouse to the tank.

Gas flows from the truck to the boom through the 1½" pipe which is attached to the meter outlet and piped along the left side of the truck to the upright. Wear and tear on hose has been eliminated, and stowing away the long gas hose discontinued.

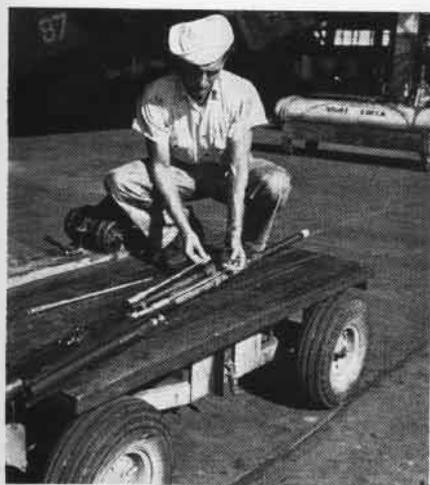
TIE RODS MODIFIED TO ALLOW ADJUSTING

As the clearance between the rack operating lever and rock roller play such an important part in the feeding of the cannon, this clearance should be checked, and adjusted, if necessary, prior to each gunnery flight.

The purpose of the tie rods which extend from the magazine slide group to a flange mounted in the wing of the plane, is to make the magazine slide a stationary group. Another purpose of the tie rods is

to allow one to make a clearance of  $\frac{1}{16}$ " between the rack operating lever and the rack roller on the feed mechanisms.

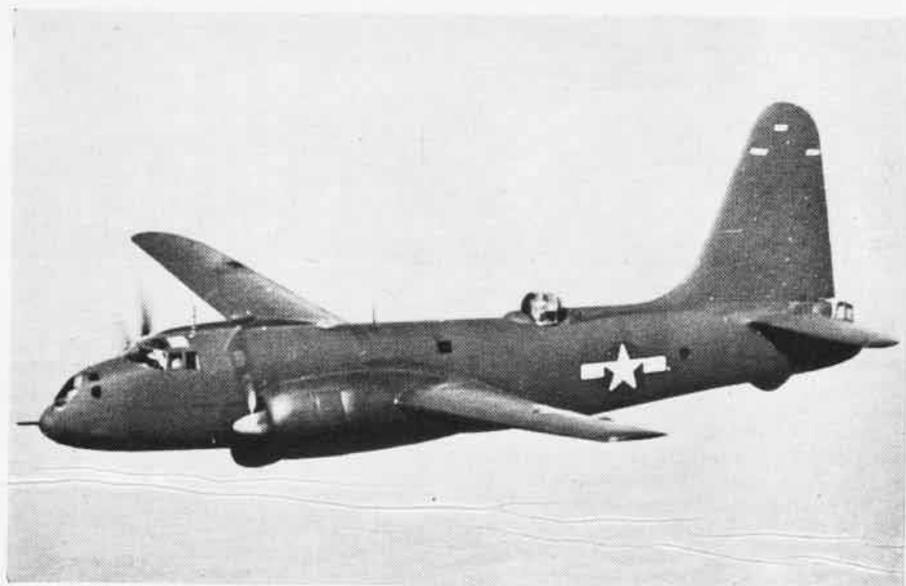
NAVY'S NEPTUNE IS ARMED DYNAMITE, WITH SPEED AND MANEUVERABILITY DOMINANT

It carries two aerial torpedoes and has a nose studded with six 20mm. cannon. The *Neptune* also boasts eight five-inch high velocity rockets under each wing. Under another set of loading conditions, the *Neptune* can carry 12 325-pound depth charges or eight 1000-pound bombs or 16 500-pound bombs. Racks will also carry four 2000-pound bombs. Top and power turrets each carry twin-mount .50 caliber machine guns.

So far, the *Neptune* has proven more efficient per pound of gross weight than some four-engined planes. An example of this may be found in the newly-designed engine nacelles. These nacelles are much smaller than those which house the same engine as on the B-29.

Though a twin engine plane the *Neptune* is large, its fuselage being 75 feet long, wing spread 100 feet and the vertical fin being 28 feet tall or almost the equivalent in height of a three-story dwelling above the ground.

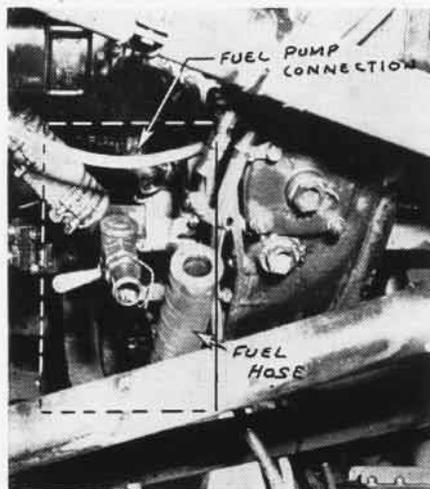
**UNCLAMPED FUEL HOSE CAUSES ACCIDENT**

fumes in the cockpit immediately after leaving the ground. Then the starboard engine started missing and cut out completely. Observers watching the plane come down saw fire in the vicinity of the starboard engine nacelle, and by the time the plane stopped, its starboard side was in flames.

Post accident inspection showed that the fuel hose from the engine driven fuel pump to carburetor was completely disconnected from engine driven fuel pump. An intensive search was made for the missing hose clamp, which simply was non-existent. Careful examination of fuel hose revealed conclusively that a hose clamp never had been installed on this section of hose at the fuel pump end. Nev-

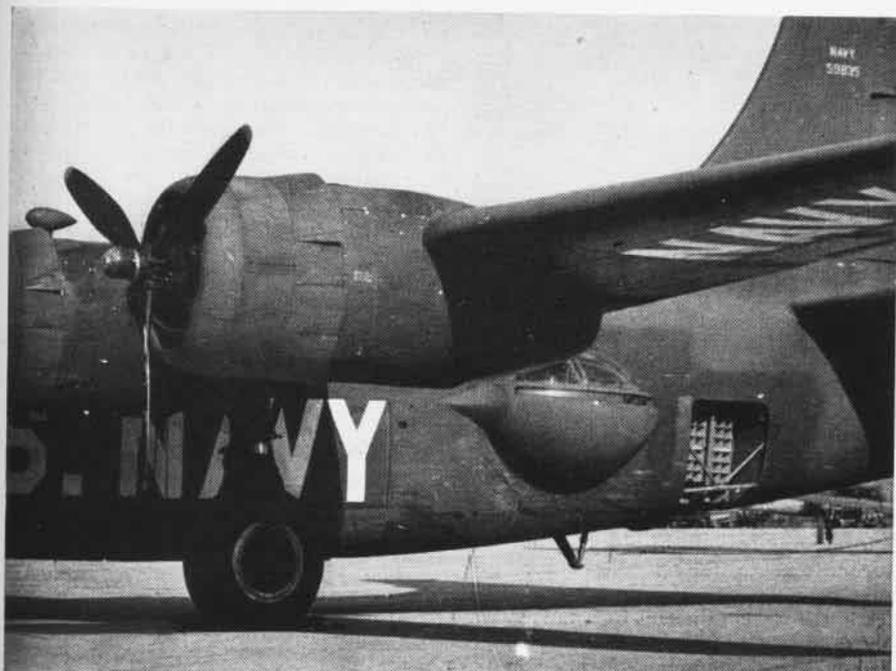
THIRTY-SIX SPEAKERS MAKE UP UNIT WHICH CAN BE TRAINED TO DIRECT THE SOUNDS

from 10,000' aloft. The PV's had to fly lower and absorbed some AA fire. Two operators run the unit, which can deliver 2000 watts of audio power to the projector, compared to 2 watts which a console type radio delivers when playing loudly in a living room. Football public address systems have up to 100 watts to make themselves audible.

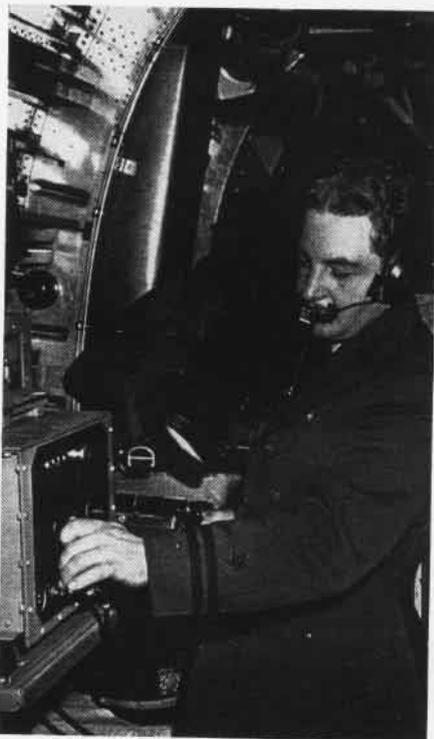
ANNOUNCER USES LIP MIKE AT AMPLIFIERS

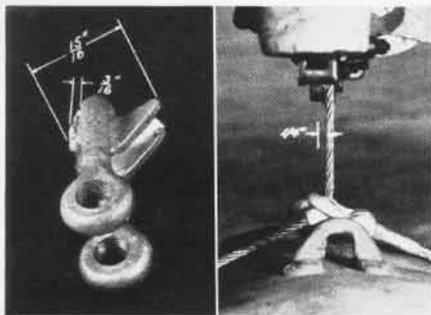
To use the adapter, the looped end is placed around the cable with the cable end attached to the adapter by use of a  $\frac{5}{16}$ " toggle pin. The cable is placed around the bomb, forming a hoisting band as shown. Added pressure on the cable at the adapter does not exceed the safety load prescribed for the Mk 7 portable bomb hoist and makes loading and unloading of bombs on Mk 51 racks and Mk 8 shackles easier. With the cable in position for hoisting the

ADAPTER MAKES CABLE INTO HOIST SLING

bomb, the adapter should be off center approximately 1" for ease in latching bomb to rack.

The adapter consists of a  $\frac{1}{2}$ " shackle to which is welded a piece of half tubing, to prevent the bomb hoist cable from being kinked. (For further information see BUORD drawing 562470.) Tests conducted with this adapter indicate that seldom will a cable have to be replaced because of wear caused by this device.

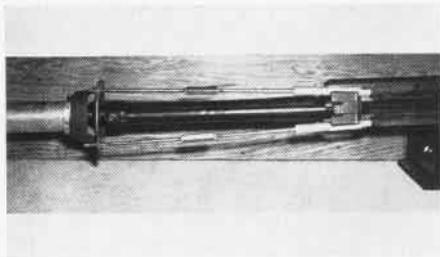
TIE RODS MAKE SLIDE GROUP STATIONARY

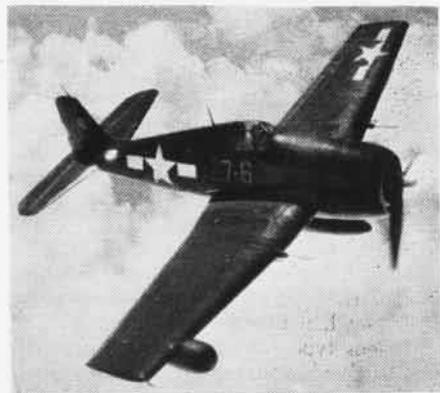
F6F EQUIPPED WITH 20 MM AND 50 CALS

Information from a former combat area has indicated a marked improvement in efficiency and performance of the 20 mm aircraft gun AN-M2. Marine Air Group Twenty Two established an excellent record in combat operations in the Ryukyu area flying the F4U-1C airplane equipped with this weapon.

During the operations 134,877 rounds were fired at enemy targets with 107 stoppages—for an overall combat efficiency of 93.5 percent of rounds fired per rounds loaded, as compared with a training average of 96.6 percent, made under ideal conditions. The air combat operations consisted of air-to-air combat, strafing

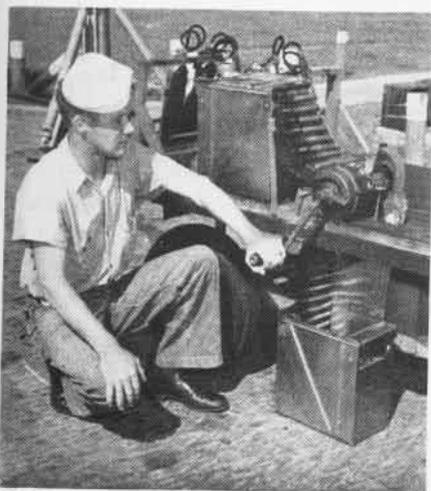
The machine is operated by one man who inserts the leading cartridge into the machine and simply cranks the belt

MOBILE AMMO CALIBRATOR IS PRACTICAL

through into a magazine can placed below the truck on which the calibrator is mounted.

The machine has been constructed so as to be usable in ready magazines where ammunition is stored in quantities to meet daily gunnery requirements. Before ammunition is checked out of the ready magazine each belt is cranked through the calibrating machine and as each round passes it is positioned exactly in the links and brushed with an oily wick. This oiling aids the extractor in withdrawing the ammunition case from the firing chamber of the gun.

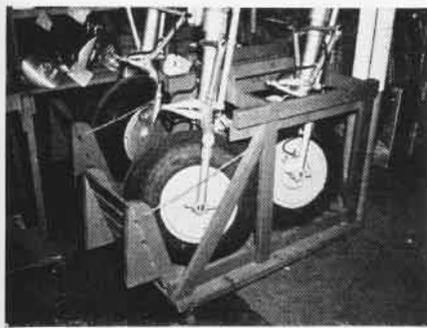
NAS CORPUS CHRISTI—The handling of SNB landing gear assemblies has been facilitated by development of a wooden dolly mounted on rollers. This dolly has

WOODEN DOLLY PROVIDES GEAR STORAGE

a hinged gate at one end. Lowering the gate will provide an incline to roll the gears onto the dolly. By rolling one gear into dolly and placing a wooden separator in position a definite compartment is provided. Another complete gear then can be rolled on and the gate raised. It is secured by a chain.

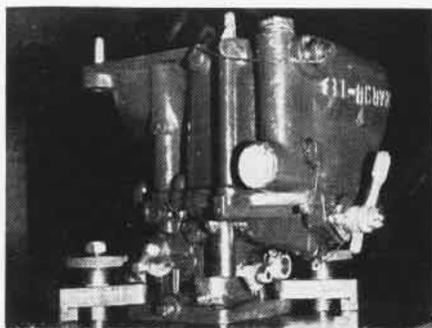
NAS PENSACOLA—A machinist at this station has developed a jig that provides a fast and efficient method of securing carburetors while removing or

JIG HOLDS CARBURETOR DURING REPAIR

installing fittings. Use of a vise often damages parts, as a moderate pressure on the throttle valve body prevents it from closing properly.

Two clamps swivel on the studs and fit the spotfaced portion of the carburetor. Compression springs are placed on the studs under the clamps to raise them and self-locking fiber nuts are placed over the knurled nuts to prevent them from running off. One turn of the speed nuts will tighten or loosen the clamps on the carburetor.

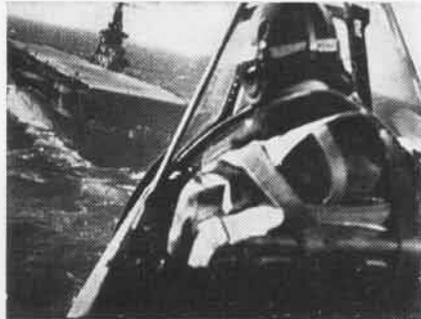
Horrors and shades of John Paul Jones. I didn't believe it could happen, especially in NAVAL AVIATION NEWS. On Page 11 of the December issue there is a swell shot of a plane in the groove for the deck of the *Ranger*. It is an excellent picture and so realistic it gave me that old feeling but how could you call it an F6F?

The cowl flaps are the tipoff and besides who would have taken the picture if it were a *Hellcat*? A gremlin no doubt.

If you check again, I think you'll find that it is a TBM-3D.

¶ Inspection by BUAER experts corroborates NANews' statement that the plane was an F6F. The picture was taken with a movie camera behind the pilot's head in a modified cockpit installation. NANews cannot send copies to individuals because transfers come too fast but it can increase total copies to an activity if requested.
