# Department of Defense Legacy Resource Management Program

PROJECT 00-109

## **Investigation of the *CSS Alabama***

November 7, 2000

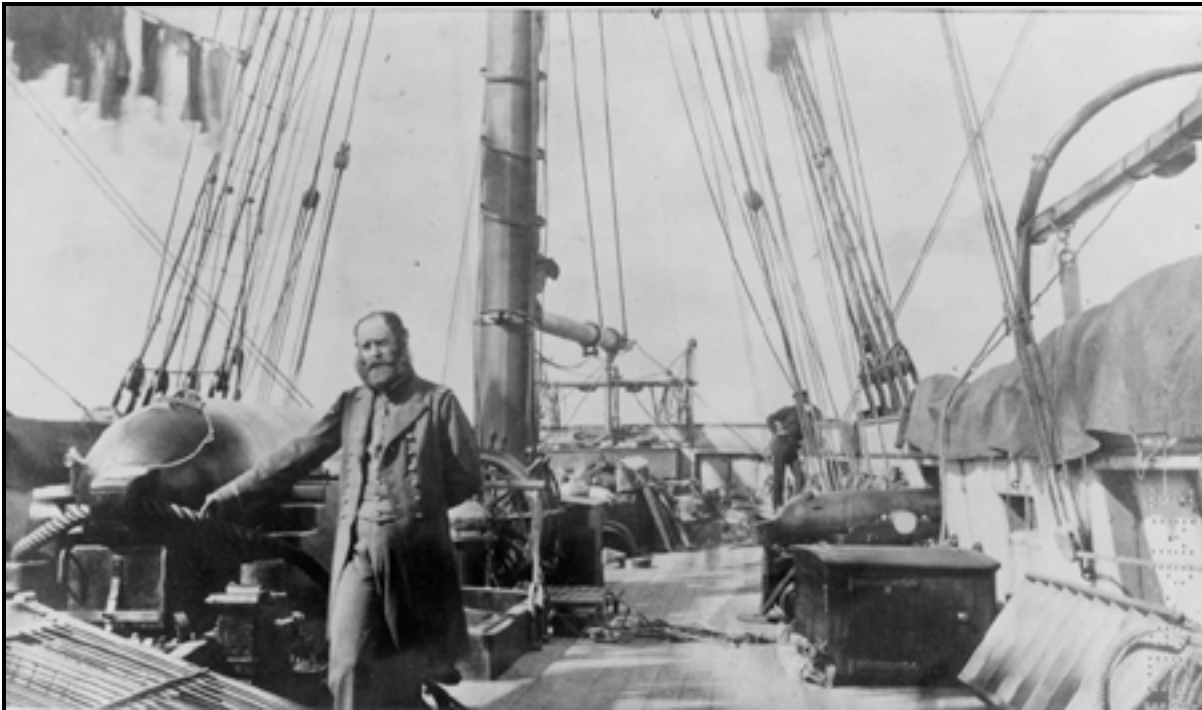
**Figure 7. Historic photograph illustrating a Fawcett, Preston & Co. 32-pounder, an ordnance chest and the tangent sight on the breech of the stern pivot gun of the CSS *Alabama*.**

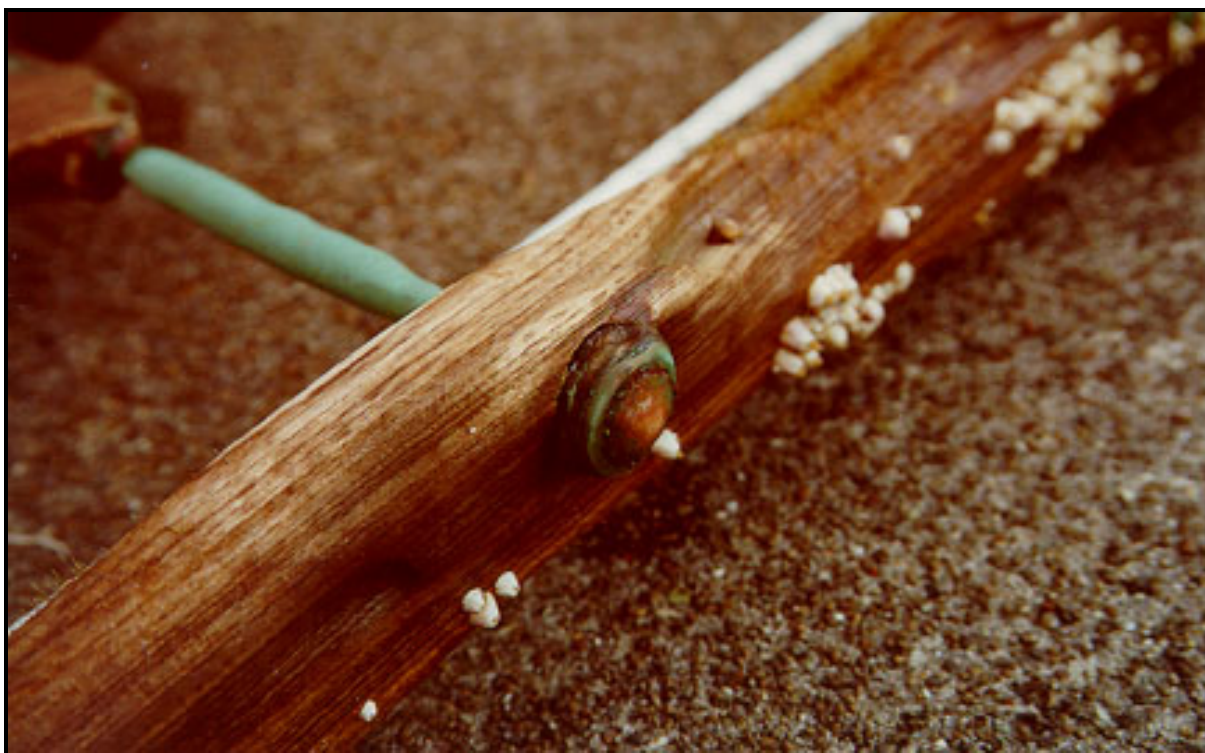
**ALS-215 Hull Fragment with Fasteners**

Artifact ALS-215 is a large fragment from the hull of the CSS *Alabama*. Although it is impossible to determine its exact location in the vessel structure the wood and fasteners suggest that it consisted of a section of deck clamp, hull planking and futtock. The multi-component artifact is made up of three different wood species. The outer portion is teak that represents hull planking. The middle section appears to be white oak and represents remnants of a futtock. The inner portion is mahogany and represents the remains of a deck clamp. Copper fasteners run through each piece and are corroded away on the inner side. The pins are peened over roves outside the teak planking.

**Artifact Dimensions:**

Length:	87.5 inches	222.25 cm
Width of Oak:		
Width of Teak:	3.6 inches	9.1 cm
Width of Mahogany:		
Pin Diameter:	.75 inches	1.9 cm
Rove Diameter:	1.5 inches	3.8cm

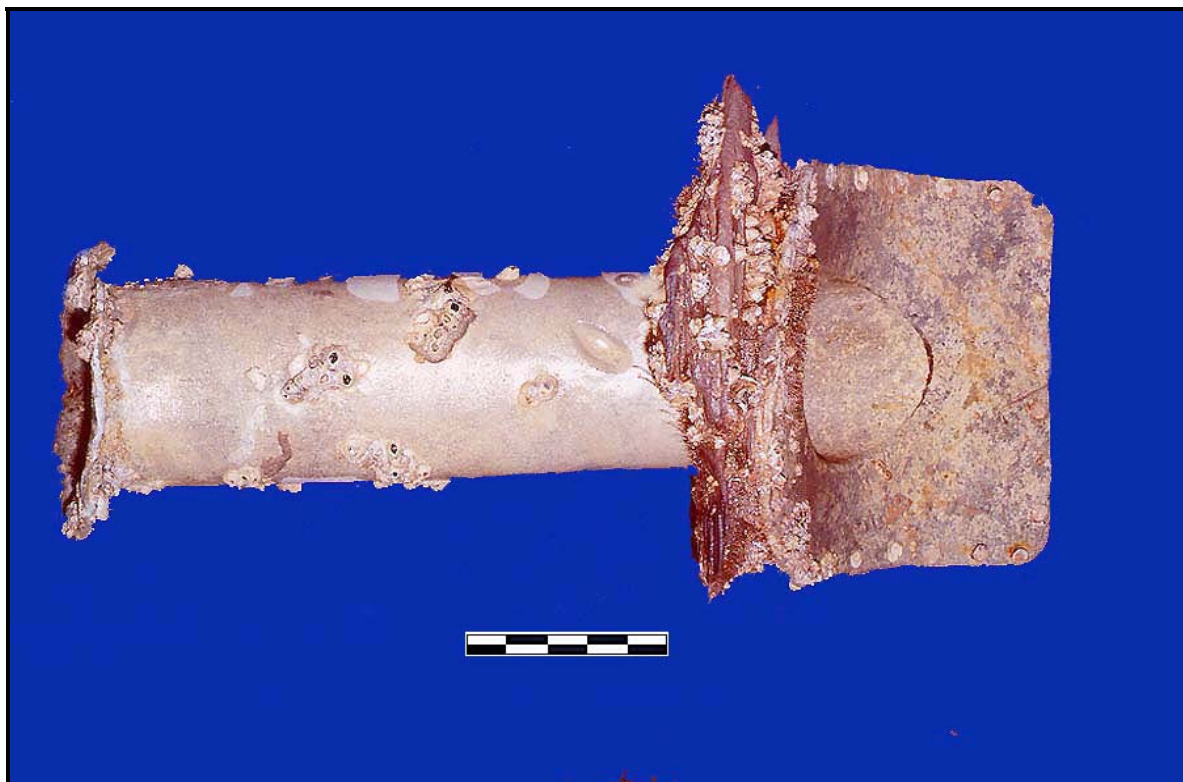
**ALS-216 Scupper**

**Artifact Dimensions:**

Length:	26 inches	66 cm
Throat Diameter	3.50 x 4.50 inches	8.9 x 11.4 cm
Tack Spacing:	1.50 inches (on center)	3.8 cm
Pipe Length:	22 inches	55.9 cm

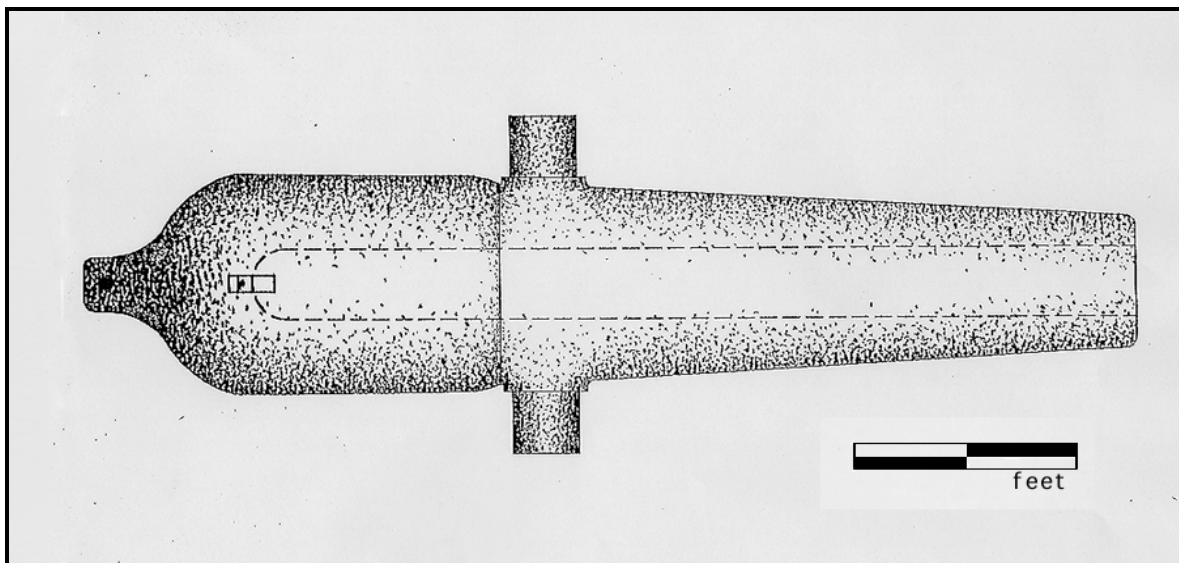
ALS-217 32-pounder Cannon

Artifact ALS-217 is a 32-pounder cast iron smooth bore cannon. The *Alabama* 32-pounder was cast for John Laird and Son by Fawcett, Preston, and Company of Liverpool, England specifically for the Confederate cruiser. Although preliminary drawings illustrate many of the design characteristics of the barrel, a critical section around the trunions and the barrel forward of the trunions remains obscured by a calcarious crust formed by deteriorating iron, seawater and sediment. The configuration of the tube is somewhat similar to the rifled ordnance designs of Captain T. A. Blakely. Although cleaning will have to be completed before a thorough assessment can be made, the barrel forward of the trunions resembles the 7-inch Blakely rifle removed illegally from the Confederate commerce raider *Florida*. That Blakely was also cast by Fawcett, Preston, and Company in 1861. Unlike the CSS *Florida* rifle which is banded, the breech of the *Alabama* 32-pounder appears to be cast and resembles a 4.5-inch Blakely rifle at Fort Pulaski, Georgia that was also produced by Fawcett, Preston, and Company in 1861. As Fawcett, Preston, and Company produced a variety of Blakely patent cannon, it is reasonable to assume that the 32-pounder might be one of his designs. However, the design of an Armstrong patent rifle in Whitby, Canada also bears a resemblance to the 32-pounder's design. According to historical data collected by Andrew Bowcock, this 32-pounder was one of four guns of this type aboard the *Alabama*. Unlike the two 32-pounder naval guns also onboard the *Alabama*, this gun has no reinforces along its length and no muzzle flare.

**Artifact Dimensions:**

Length:	105.75 inches	2.69 m
Bore Diameter:	6.40 inches	16.26 cm
Breech Diameter:	21.50 inches	54.6 cm
Muzzle Diameter:	12.25 inches	31.1 cm
Trunion Diameter:	6.50 inches	16.5 cm
Bore Length:	89.75 inches	2.28 m

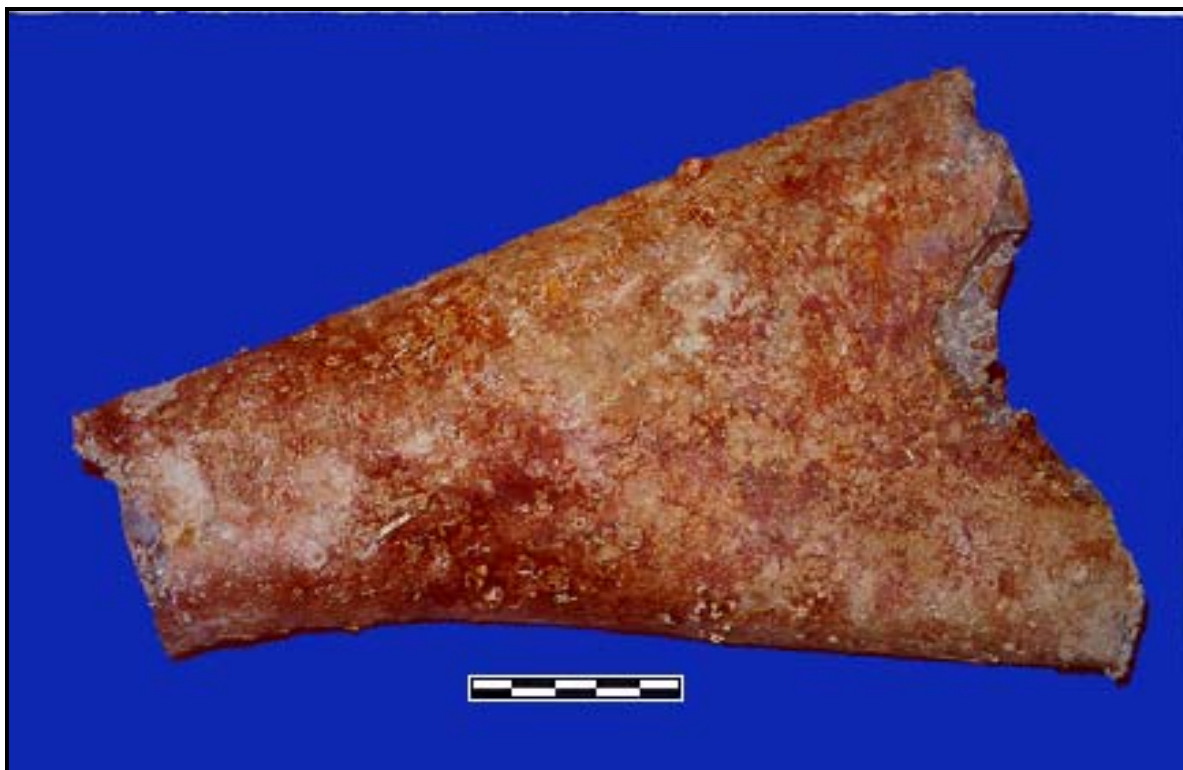
**ALS-219 Port Light**

**Artifact Dimensions:**

Lens Diameter:	5.50 inches	14 cm
Rim Diameter:	6-7 inches	15.24-17.78 cm
Lens Thickness:	.50 inches	1.27 cm
Sleeve Thickness:	.19 inches	.48 cm
Sleeve Length:	24 inches	61 cm
Sleeve Diameter:	7-16 inches	17.78-40.54 cm

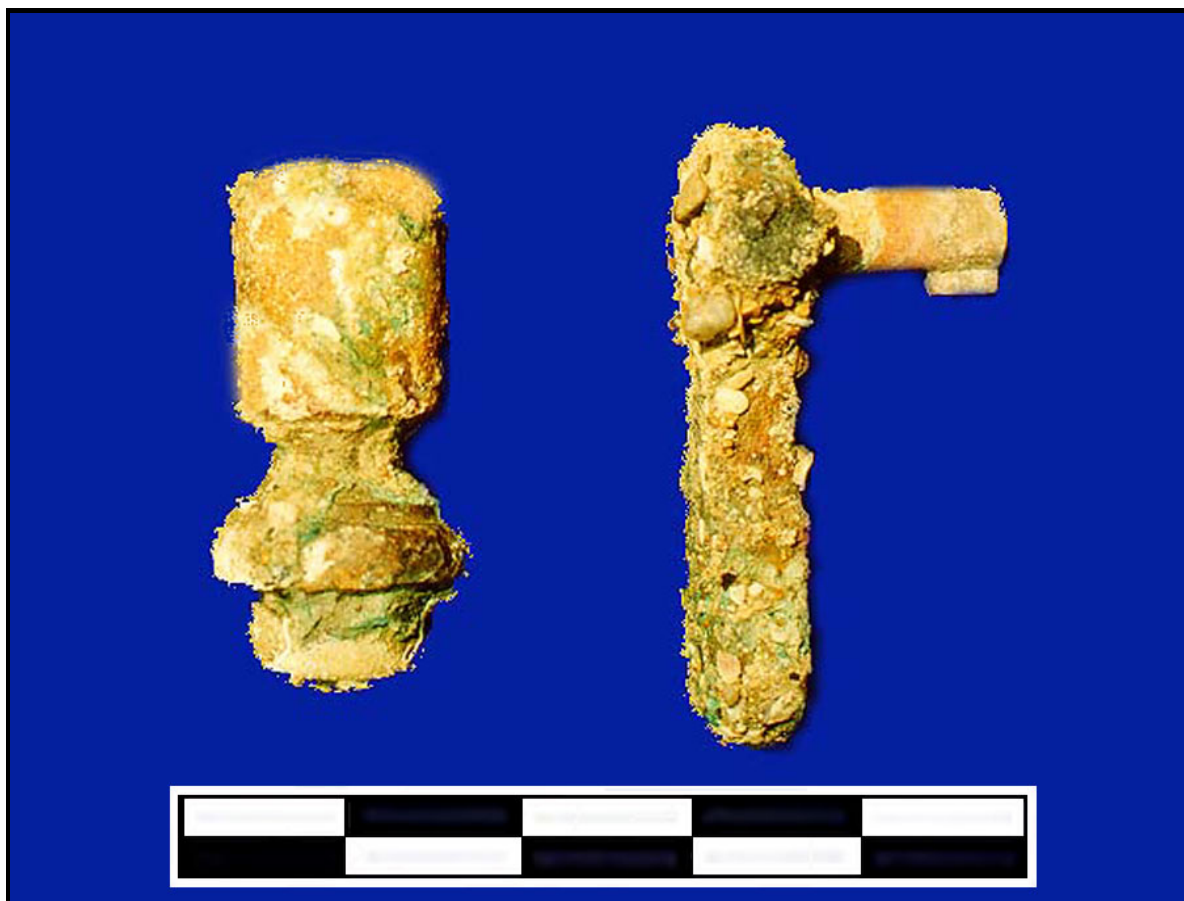
ALS-222      Lever Lock Mechanism

Artifact Dimensions:

Lever Length:	4.19 inches	10.64 cm
Shaft Diameter:	.63 inches	1.6 cm
Shaft Length:	1.50 inches	3.81 cm
Receiver Diameter:	1.38 inches	3.5 cm

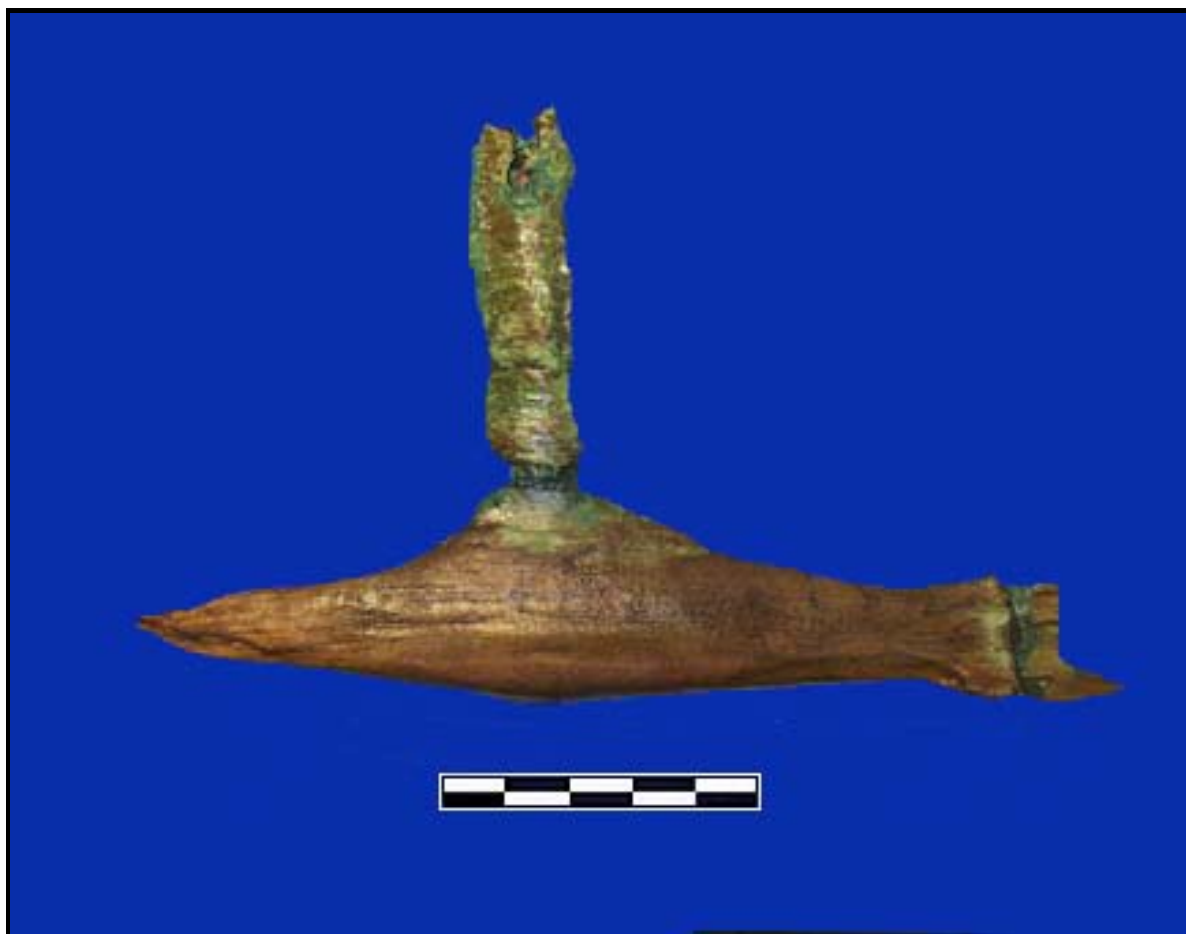
ALS-223 Hull Fragment

Artifact Dimensions:

Length:	15.90 inches	40.4 cm
Teak width:	3.75 inches	9.52 cm
Oak width:	9.00 inches	22.9 cm
Pin Diameter:	.75 inches	1.9 cm
Rove Diameter:	1.50 inches	3.81 cm

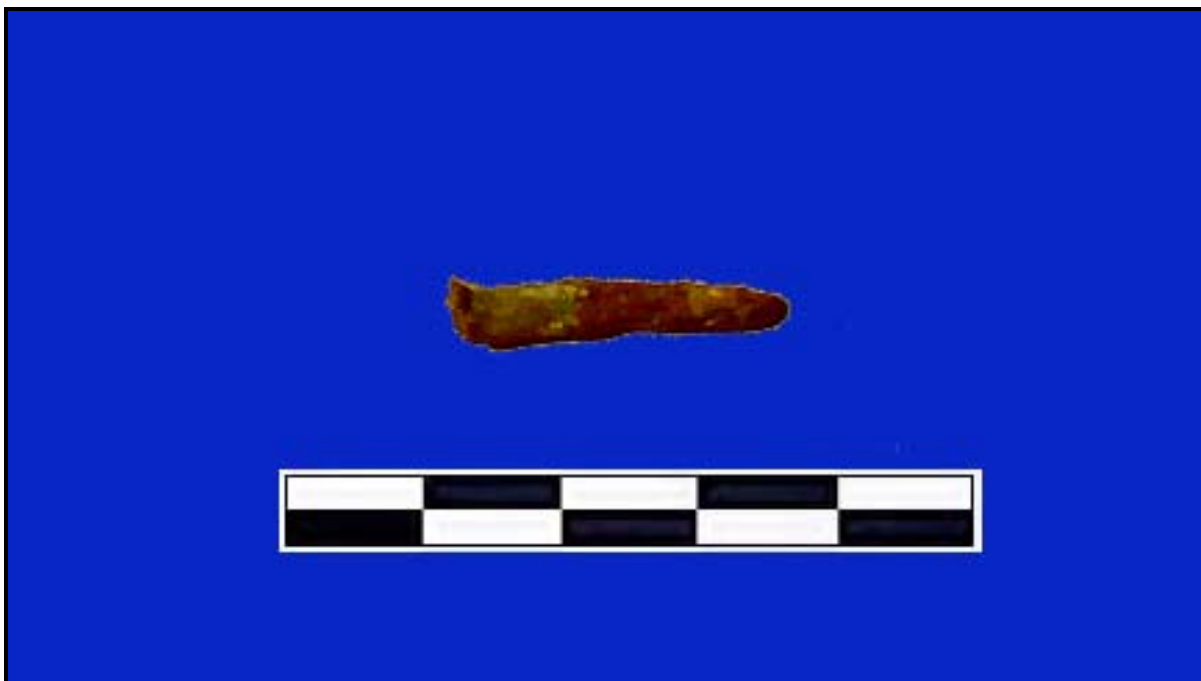
**ALS-226 Tack**

Artifact ALS-226 is a square brass tack that was used to fasten the rectangular flange of the lead scupper to the deck. Little can be ascertained about the shape of the head as it is badly corroded. However, the tack appears to be a common sheathing tack of the type used to attach copper sheathing to the hull of ships.

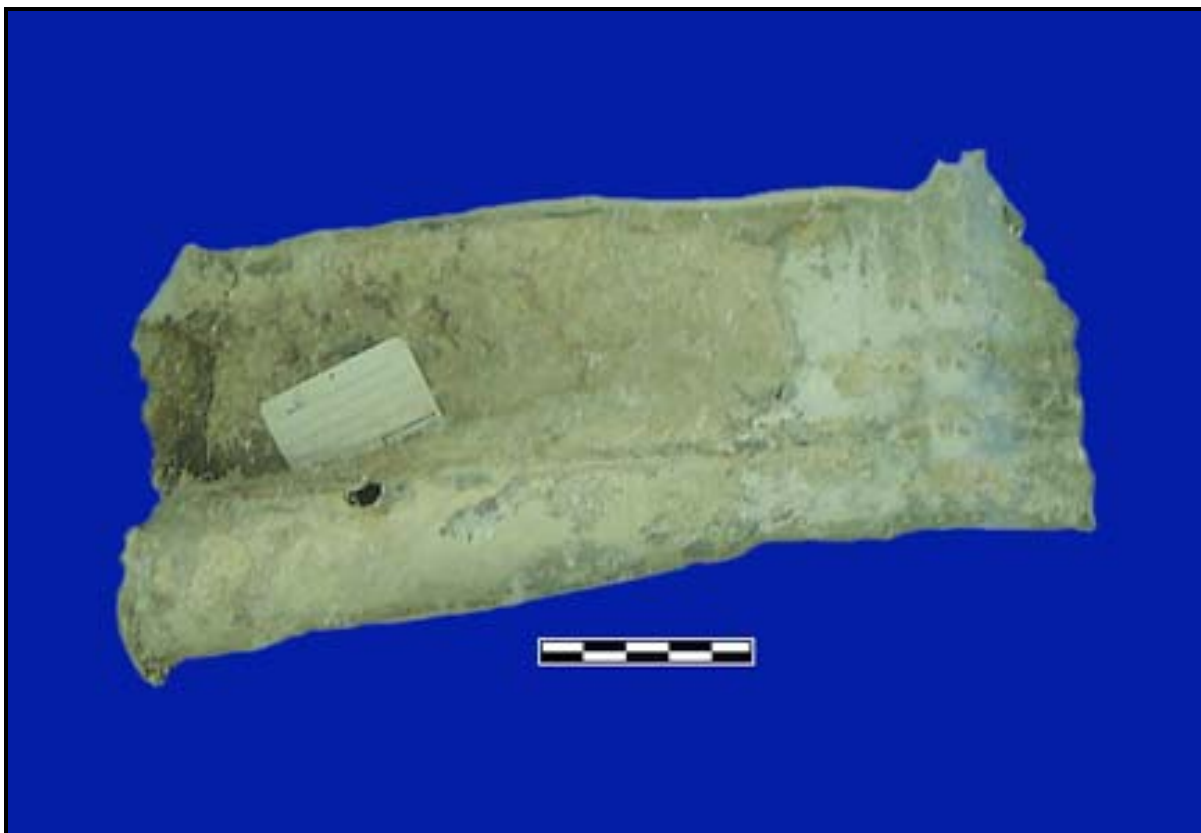
**ALS-228 Port Light**

**Artifact Dimensions:**

Lens Diameter:	5.50 inches	14 cm
Rim Diameter:	6-7 inches	15.24-17.78 cm
Lens Thickness:	.50 inches	1.27 cm
Sleeve Thickness:	.19 inches	.48 cm
Sleeve Length:	24 inches	61 cm
Sleeve Diameter:	7-16 inches	17.78-40.64 cm

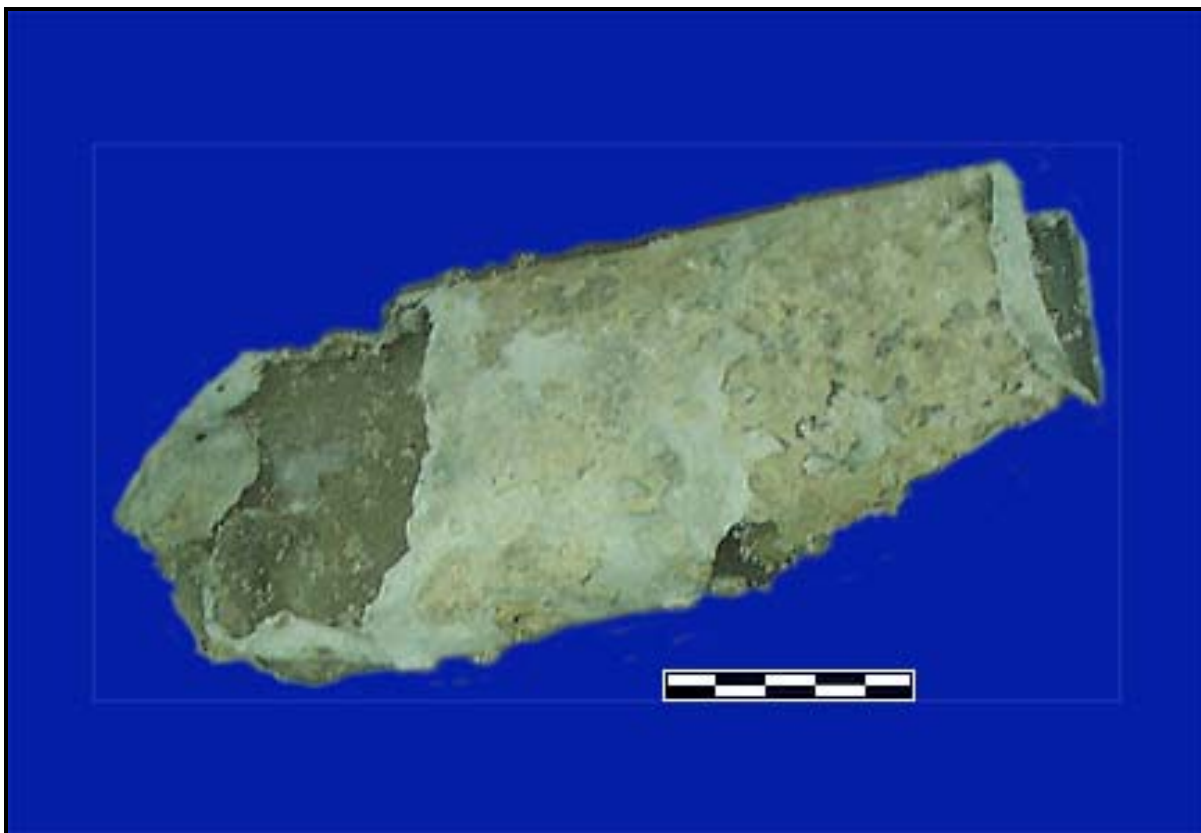
**ALS-229 Port Light**

**Artifact Dimensions:**

Lens Diameter:	5.50 inches	14 cm
Rim Diameter:	6-7 inches	15.24-17.78 cm
Lens Thickness:	.50 inches	1.27 cm
Sleeve Thickness:	.19 inches	.48 cm
Sleeve Length:	24 inches	61 cm
Sleeve Diameter:	7-16 inches	17.78-40.64 cm

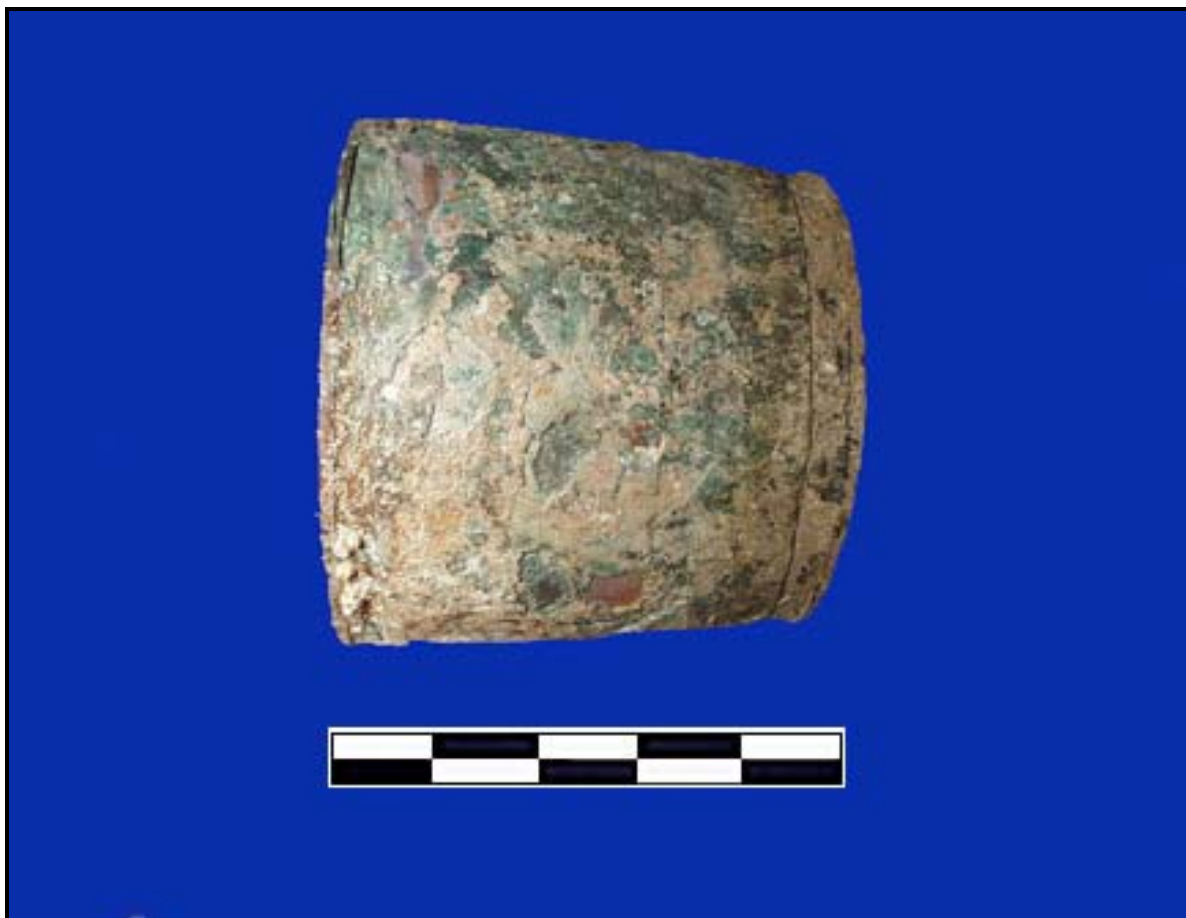
**ALS-231 Port Light Brass Rim**

**Artifact Dimensions:**

Lens Diameter:	5.50 inches	14 cm
Lens Thickness:	.50 inches	1.27 cm
Rim Diameter:	6-7 inches	15.24-17.78 cm
Rim Length:	5 inches	12.7 cm

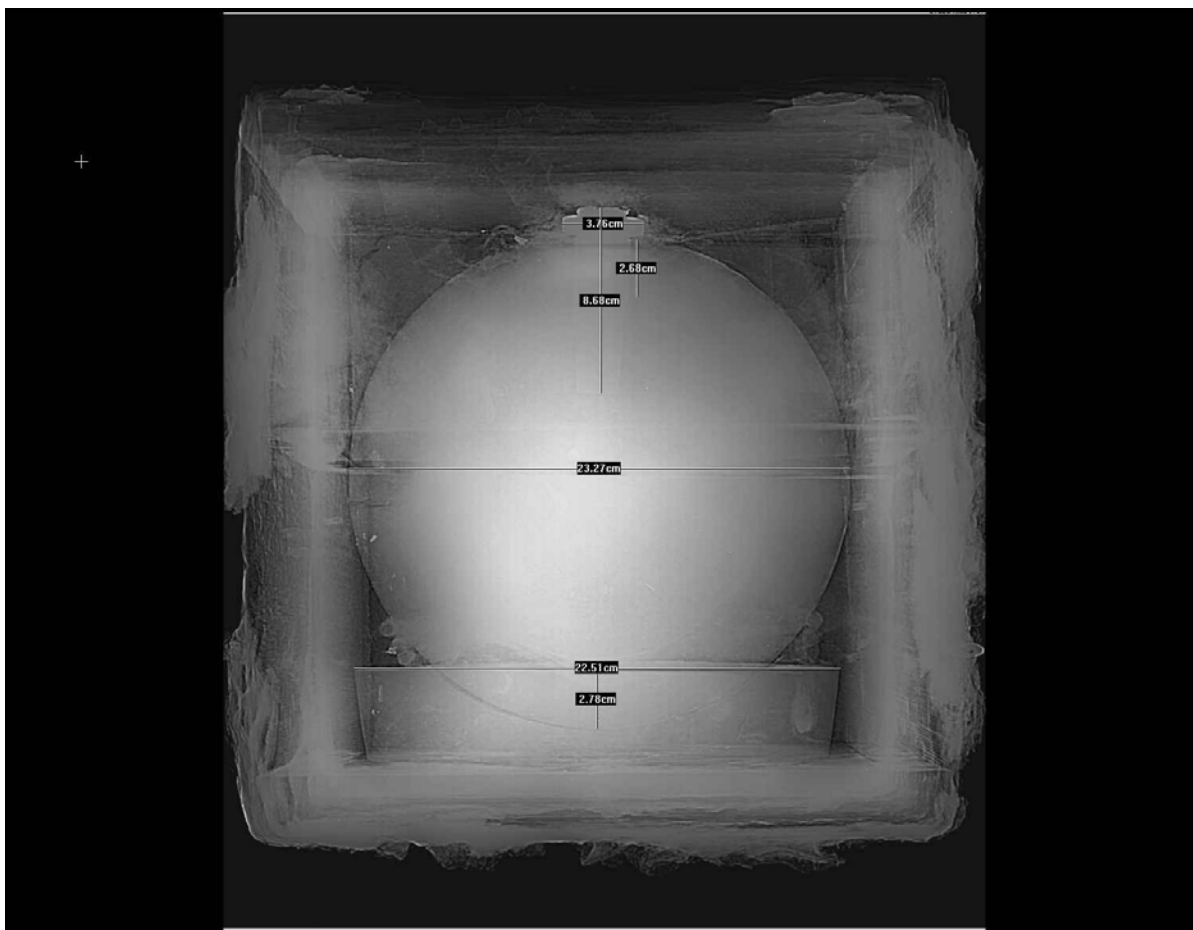
**ALS-233 Wood Shell Container**

Artifact ALS-233 is a simple six-sided wooden box. No hinges or openings are readily apparent. Box edges are joined with a simple nailed butt joint. Remnants of what appear to be a leather covering survive. The leather was attached to the box with copper tacks. The contents of the box have not been identified, however iron oxide residue leaking through the seams indicates that at least some of the content material could be iron.

Length:	10.50 inches	26.7 cm
Width:	10.50 inches	26.7 cm
Depth:	10.00 inches	25.4 cm
Wall Thickness:	.88 inches	2.23 cm
