NAVAL AVIATION

NEWS

Combat Information Center
Ward Island • Atom Bomb
Flight Test Telemetering

June 1946

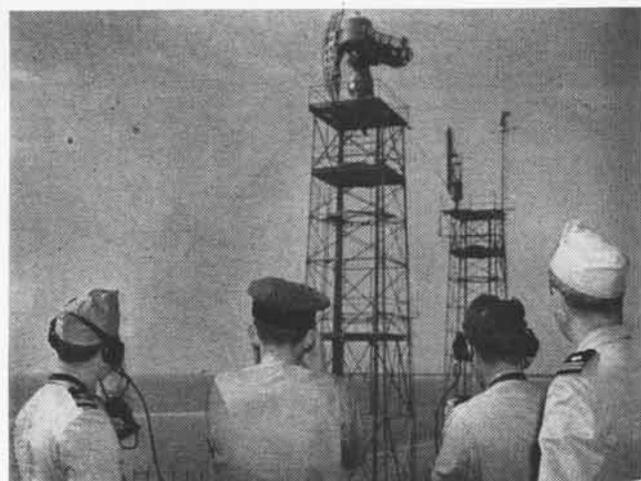
Atop the tower at King and Prince student officers guide planes in on visual intercept. Note CXHR radar antenna on tower

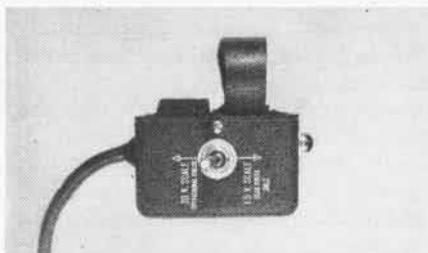
TOP VIEW OF UNIT SHOWS TOGGLE SWITCH

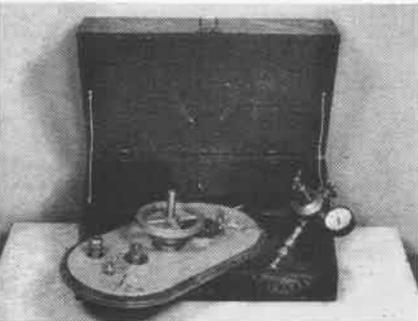
PRESSURE PANEL TESTS PBV FUEL TANKS

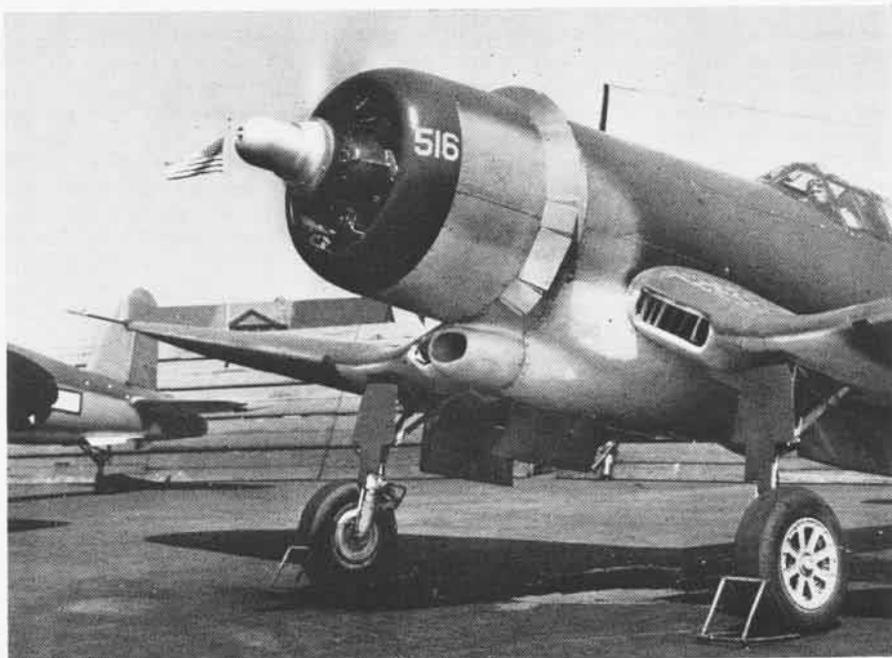
NEW TURBO-SUPERCHARGER IS INSTALLED WITHIN COWLING BUT REMAINS AIR COOLED

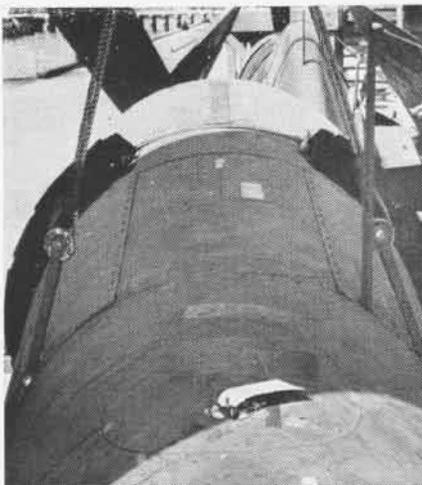
ASO APPROVES PEARL HARBOR'S F4U HOIST 15,000-lb. jerk and proved satisfactory.
