NAVAL AVIATION

NEWS

October 1946

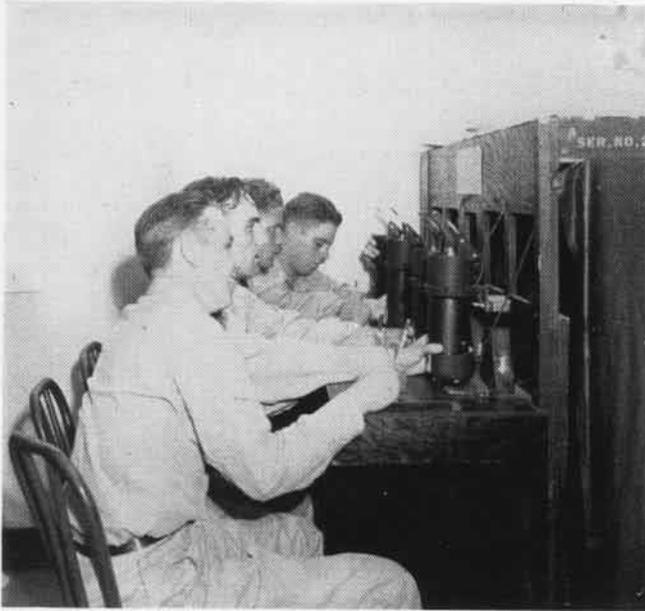
Smile of nearest student indicates a Jap in the sights. Idea of device is to mark when aircraft at end of tunnel is in range

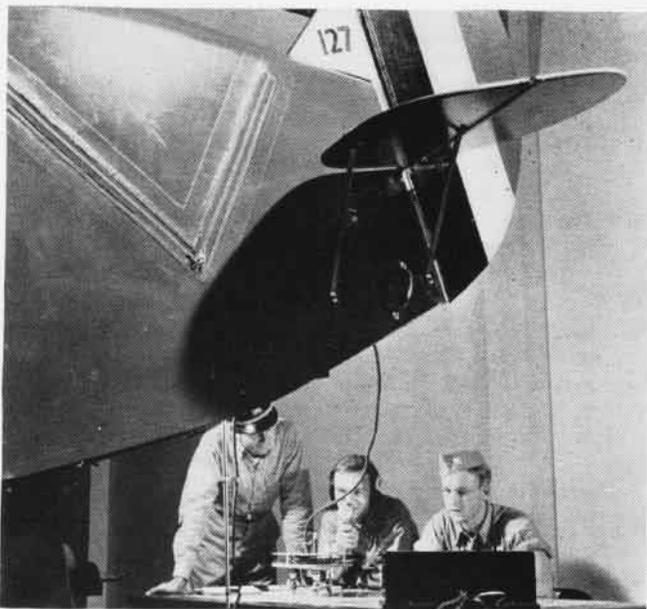
Links to the left of me, Links to the right of me — Pilots never outgrow the box-like training aid, symbol of instruments

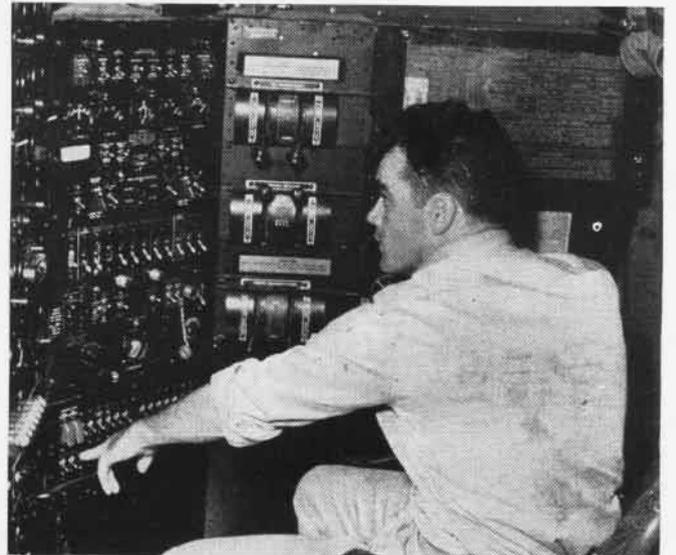
Mock-up devices such as this one being checked-out by a student-officer, an aspiring flight-engineer, are used quite extensively

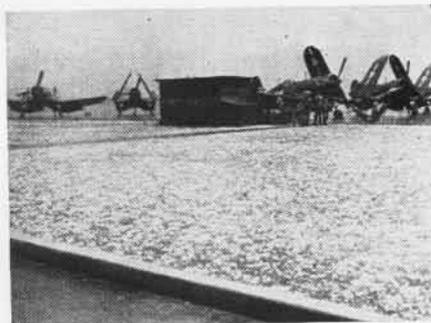
FREAK FLORIDA HAIL GIVES NO WARNING

All fabric surfaces such as flaps, ailerons and flippers on 45 airplanes were damaged. Complete fabric resurfacing was required on one CH-2 and on three N2S aircraft. Several buildings suffered broken windows and slight damage to paint surfaces, awnings and roofing. The canvas tops of Navy motor vehicles were riddled.

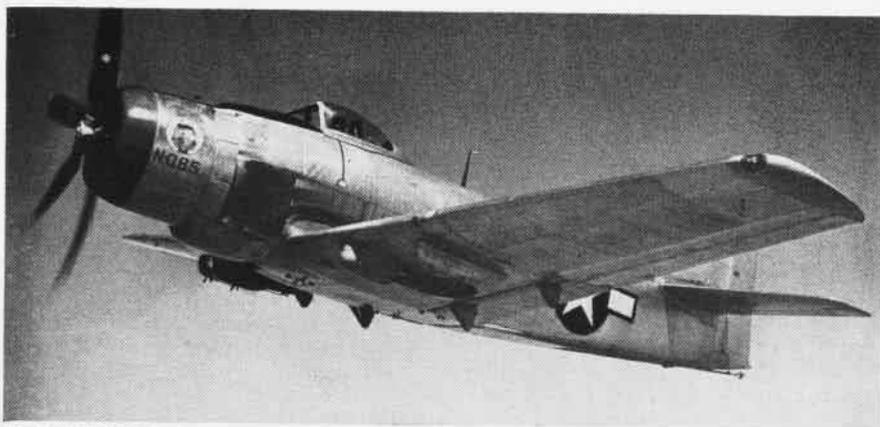
NEW SKYRAIDER CARRIES BOMBS, TORPEDOES EXTERNALLY TO BOOST GET-AWAY SPEED

Decision to carry the bombs and torpedoes externally insures the plane maximum going-away speed after dropping its load, whereas a built-in bomb bay would have cut this speed. Three external bomb racks permit carrying bombs, torpedoes, Tiny Tim rockets, 5" HVAR's and droppable fuel tanks.

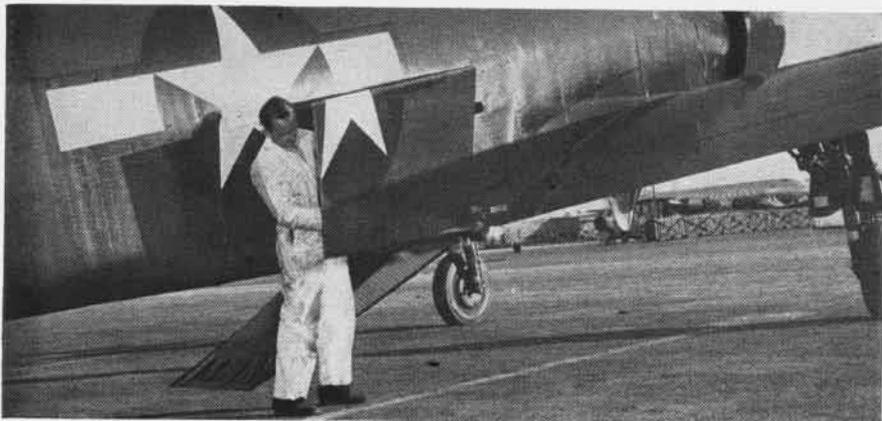
THREE FUSELAGE FLAPS REPLACE OLD BANANA-PEEL TYPE TRIED ON EARLIER BTD PLANE

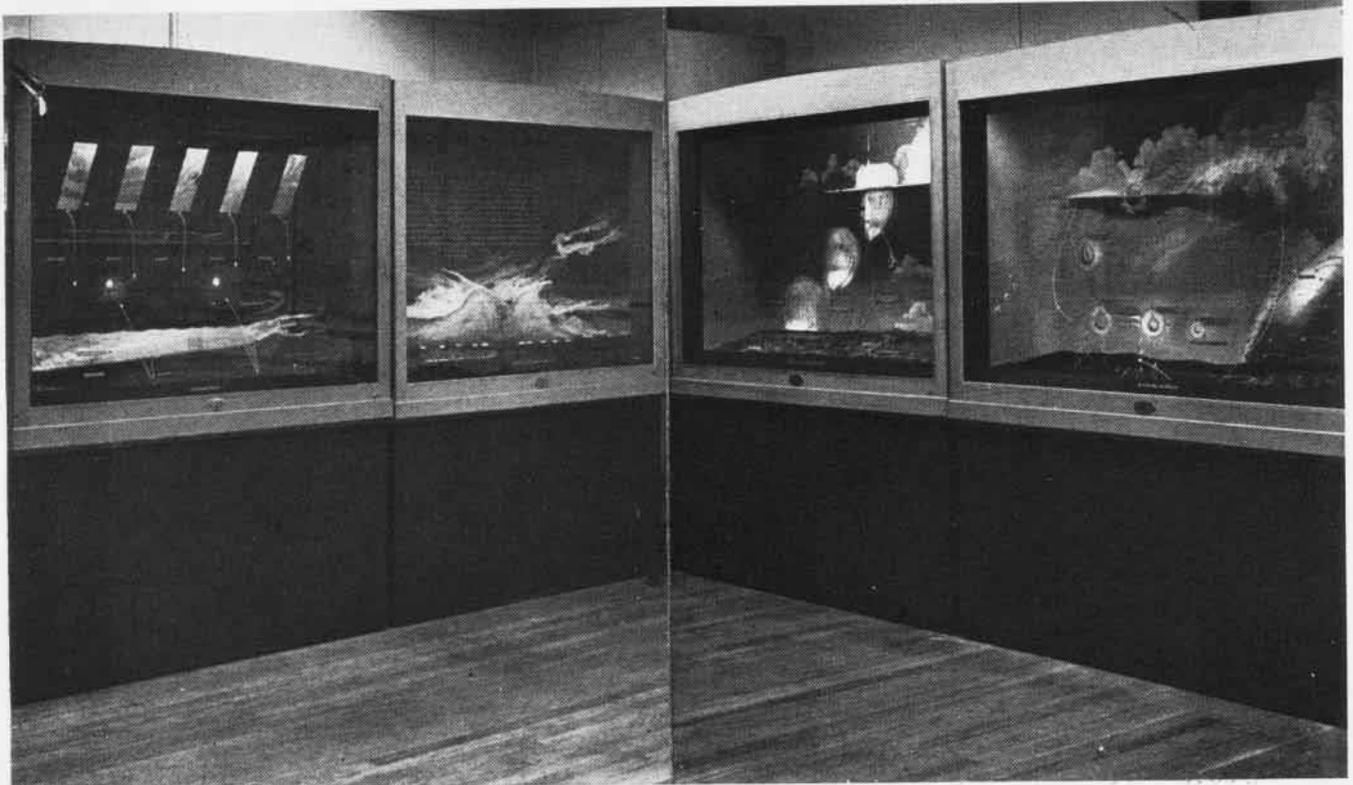
THREE-DIMENSIONAL WEATHER MODELS GIVE STUDENT PILOTS VIVID PICTURE OF ATMOSPHERIC PROBLEMS ENCOUNTERED IN FLYING

Four sets have been constructed, with two more in process. One set will be used at Annapolis, another at the school for Aerographer's Mates, NAS LAKEHURST, New Jersey. The other two have been assigned to Pre-Flight School, Ottumwa, Iowa, and NATT, NAS PENSACOLA. The models were procured through ORI, Special Devices.

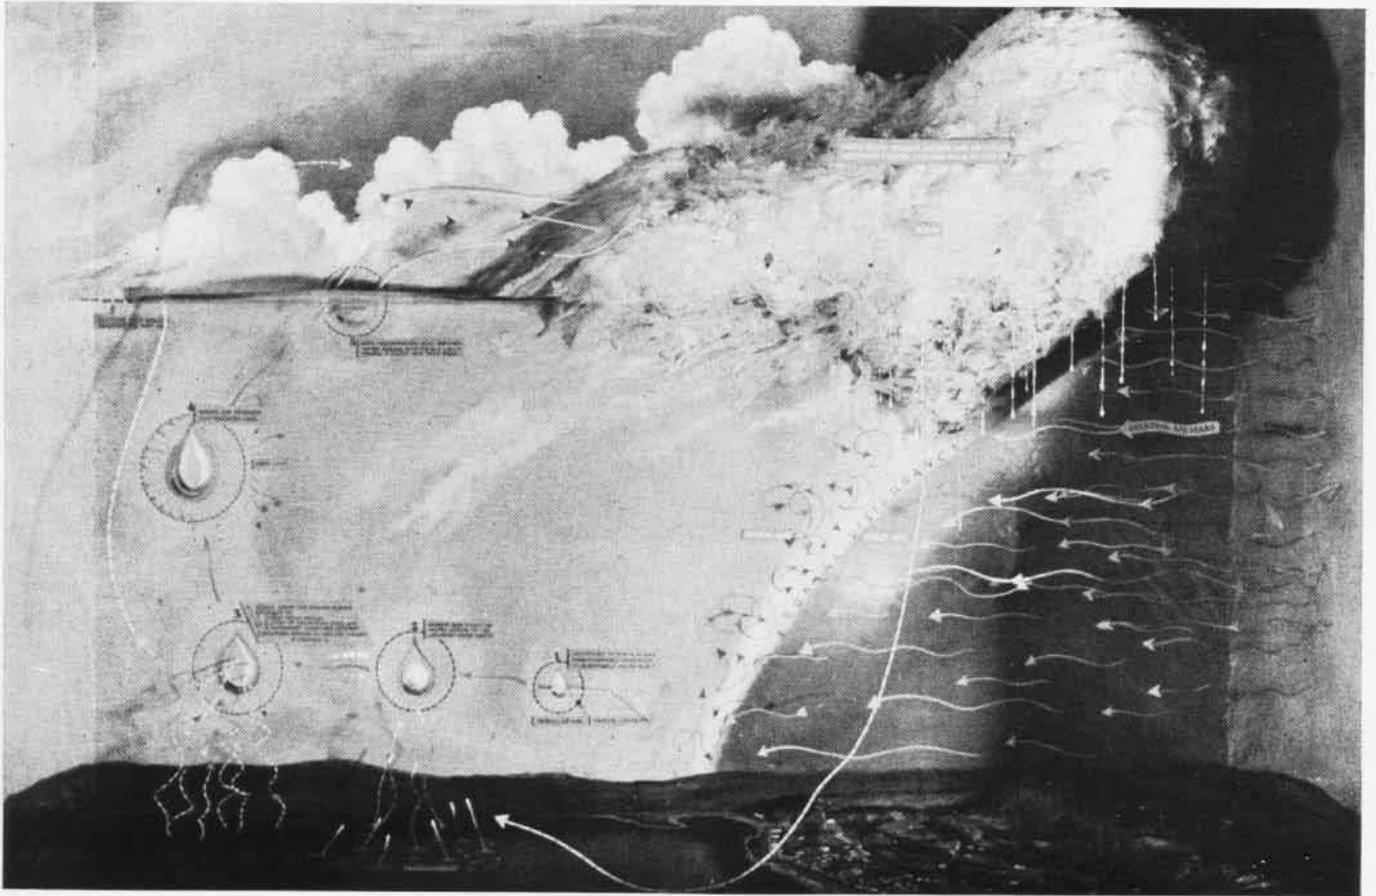
↑ **Rain** cycle begins when warm air gathers vapor over water. Process is made visual in weather model showing masses of vapor saturated air rising toward condensation level

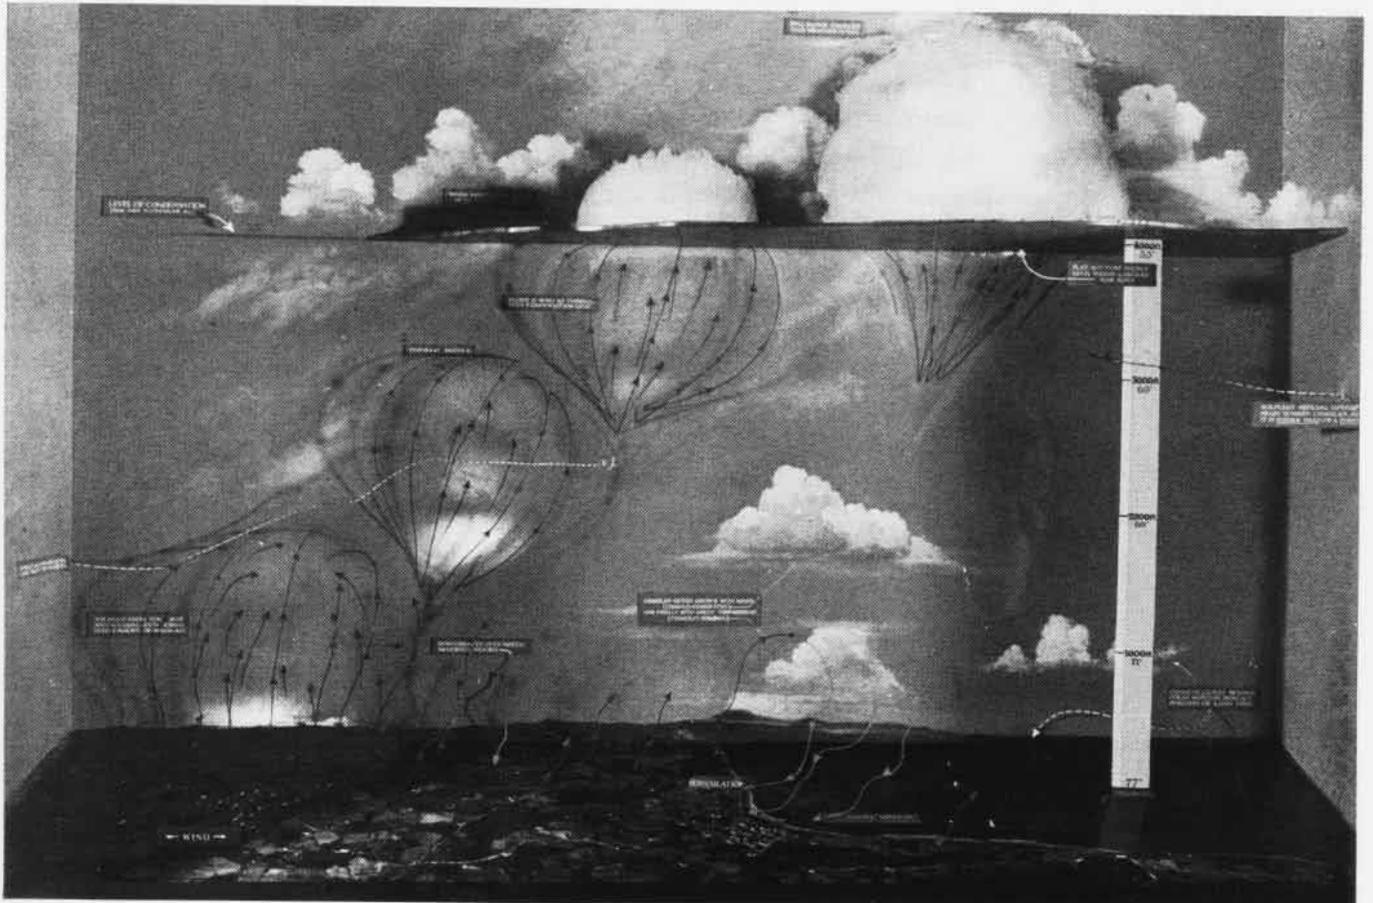
Birth of a cumulus cloud is portrayed in this model. Sun, wind and water take part in development from turbulent air to full grown clouds. Art joins science in teaching ↓

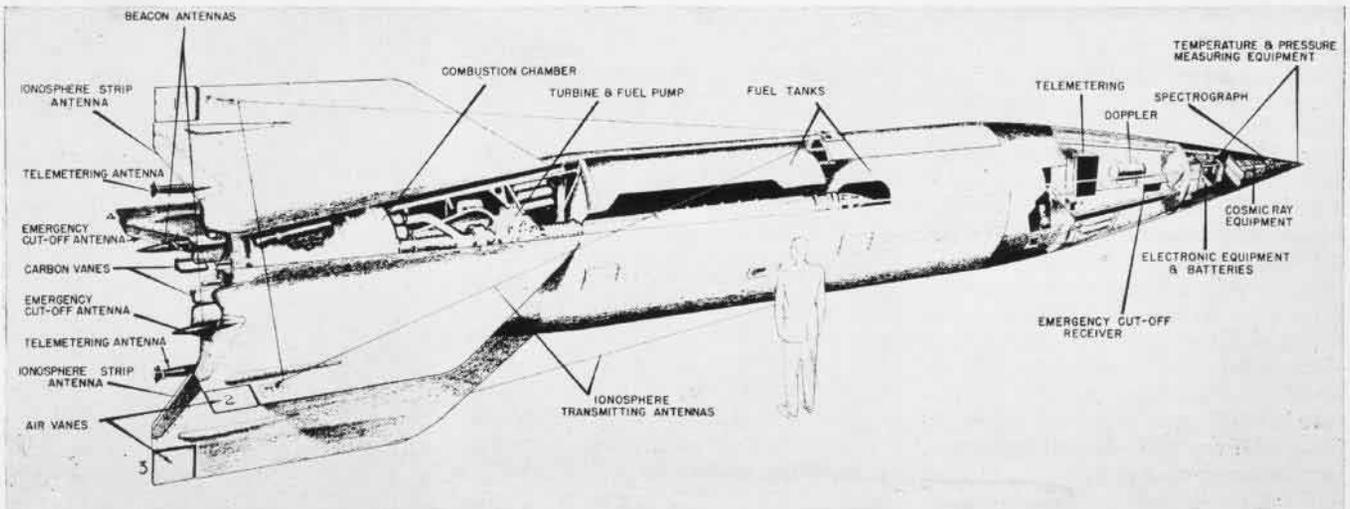
DIAGRAM SHOWS EXTENSIVE INSTRUMENTATION USED IN RECORDING UPPER AIR TESTS; SPECIAL WARHEADS WERE DESIGNED BY NRL

Consisting of heavy lead blocks to sort out "primary" particles from outer space and sensitive counters to detect them, the telescopes send a radio signal each time a particle is detected. These signals are recorded on a moving strip.

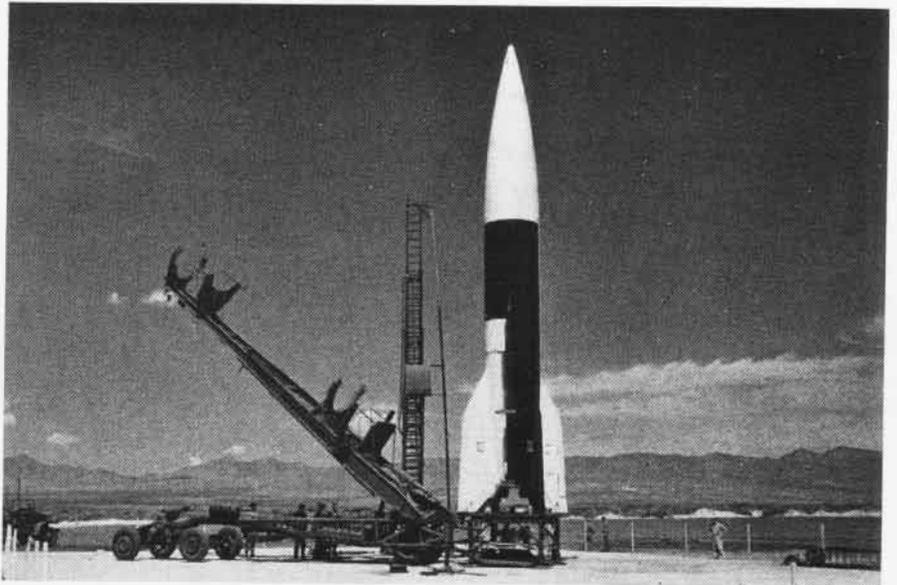
ARMY PHOTOS SHOW V-2 MISSILE READY FOR FIRING TO ALTITUDES OF OVER 100 MILES

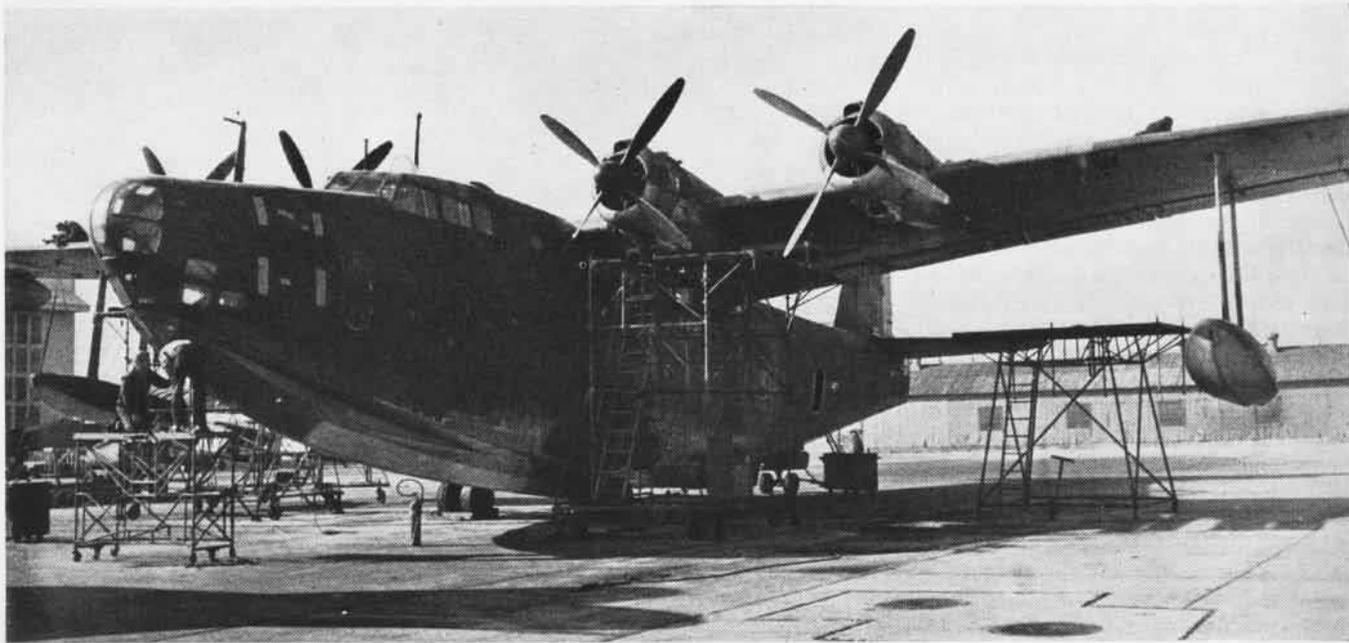
FLIMSILY-MADE JAP EMILY ON RAMP AT NORFOLK, WHERE IT IS BEING REPAIRED SO THAT IT WILL FLY FOR TECHNICAL STUDY

Necessary repairs, rewiring of ignition harness, check and test of all accessories—were made in the shops while engines remained in the plane. They gave satisfactory performance in preliminary run-ins, contrary to expectations. Next steps are evaluation test and weight and balance computations.

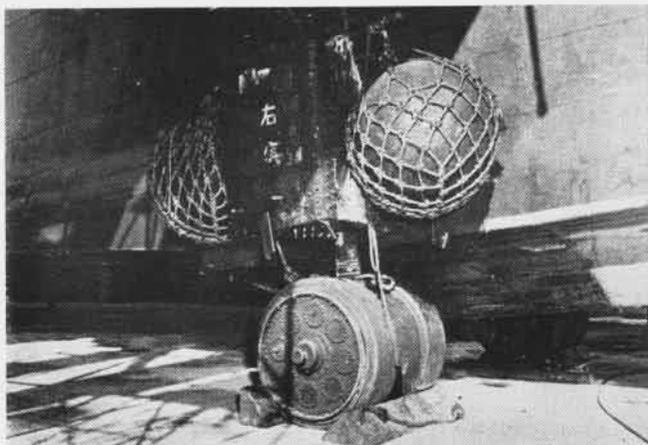
ODD JAP BEACHING GEAR WITH FLOAT BALLS HAD TO BE FIXED

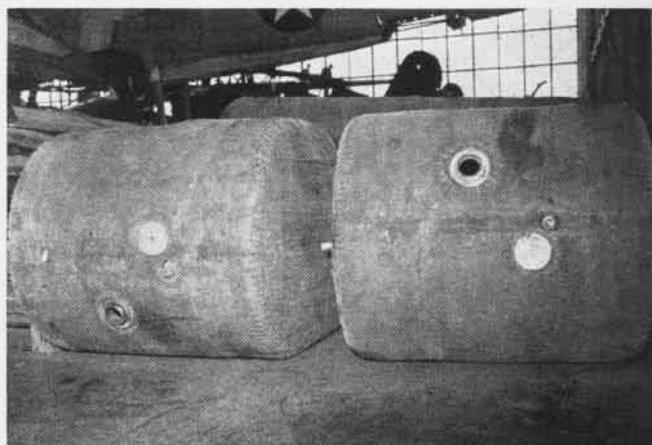
AUXILIARY HULL TANKS WERE TOO FAR GONE TO BE REPAIRED

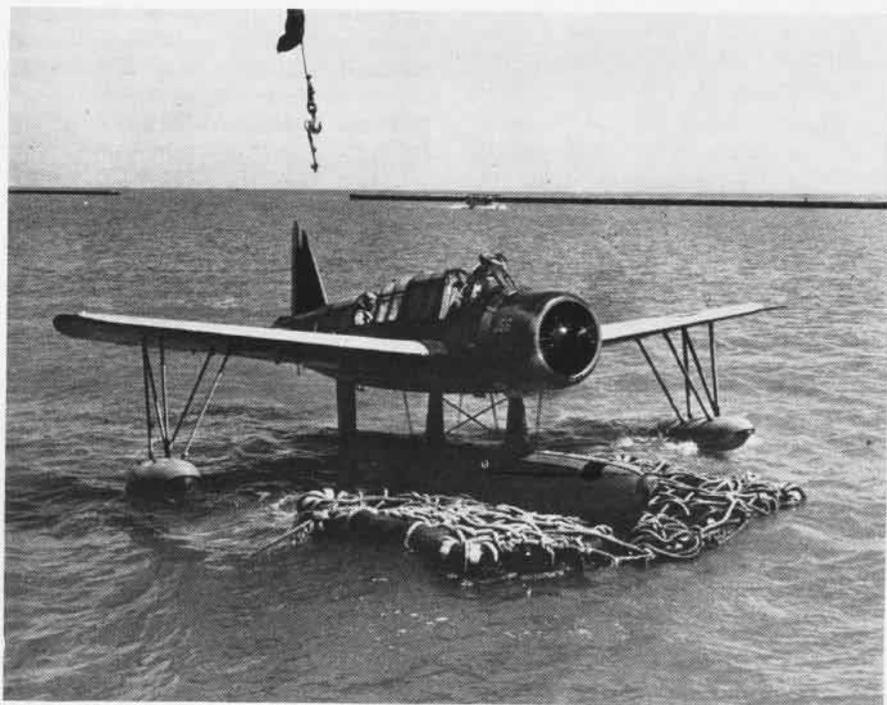
USE OF OLD TIRES FOR BEACHING SEAPLANES SAVES SQUADRON TIME AND MANPOWER

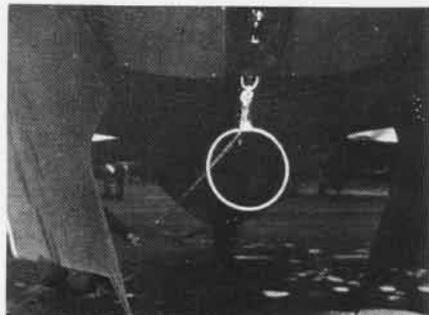
DEVICE PROVIDES SIMPLE SLEEVE DROP

BuAer Armament Division has initiated action to provide a target release for F8F airplanes, but until such time as this release becomes available in quantity, the method suggested provides a simple, inexpensive release for this type of target.

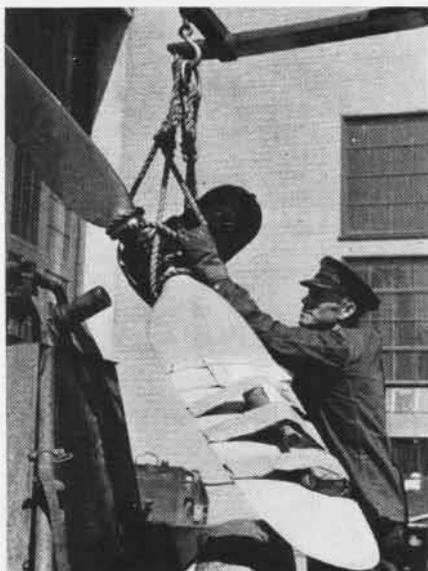
FORK LIFT HOOK PICKS UP A PROPELLER

The attachment is quite simple, consisting of a crane hook supported by a structural channel. The channel sits on top of the fork and is held in place by straps which are welded to it. Since the hook can be easily detached, it does not interfere with using the lift in the conventional manner. The hook is carried on the lift when it is not in use.

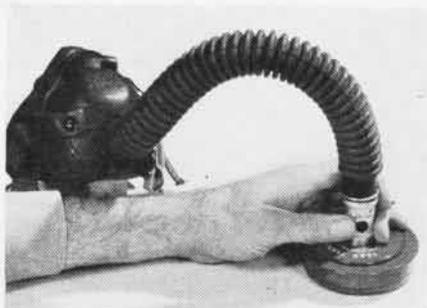
HOSE OF MASK PLUGS IN THE CONNECTOR

All these testers are considered satisfactory for field testing to detect poorly-fitted masks. The usefulness of the pocket-type volumetric mask leaktesters can be increased by the addition of a breathing vent. Addition of the breathing vent in the leaktester enables more accurate testing by decreasing the breath-holding time, lessens psychological and physical disturbance to the subject, and makes possible quicker and better checks of the subjects'

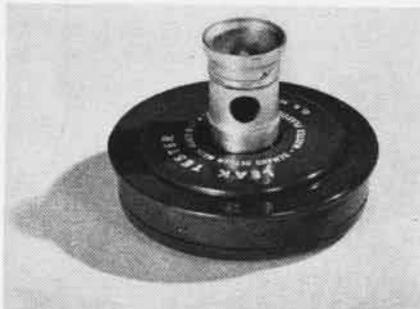
SEALING WAX HOLDS CONNECTOR IN PLACE

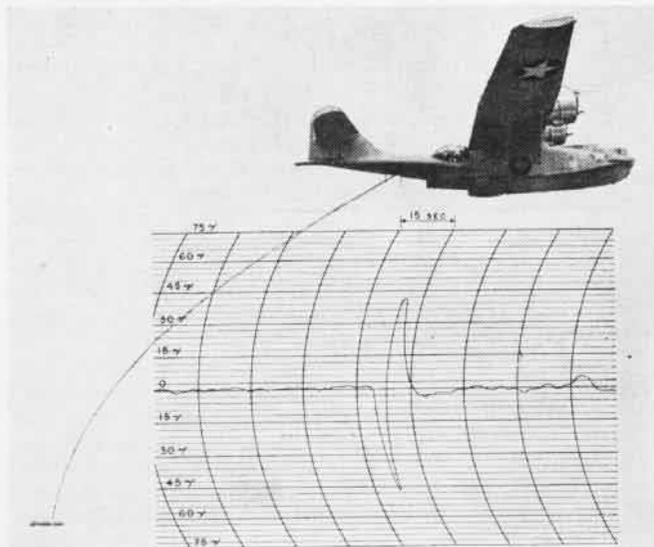
A blip registers on the recorder as a PBY equipped with a magnetic airborne detector flies over remains of a sunken tanker.

Although petroleum has no magnetic properties, possible places of oil accumulation can be determined by the surrounding rock formations. A recorded pattern for possible oil deposit narrows the areas that land parties must evaluate.

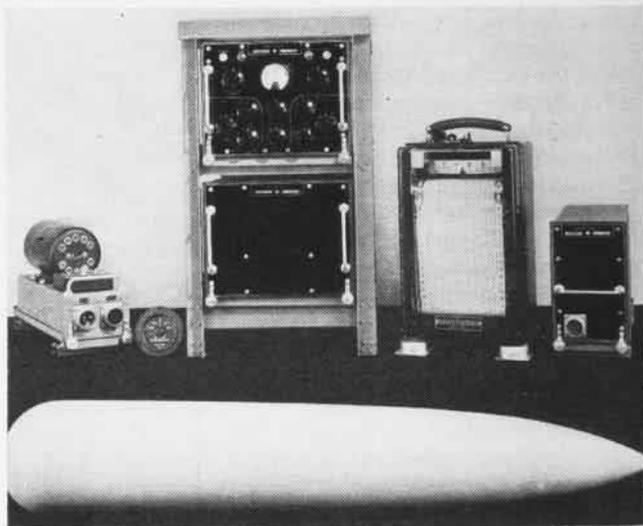
Assembly of principal ASQ equipment includes two power units, remote signal meter, main control panel, recorder, and detector.

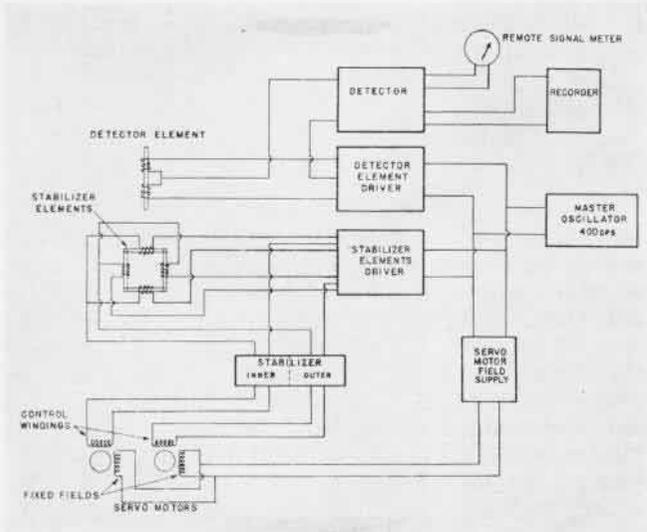
A simplified diagram shows the arrangement of AN/ASQ components. The detector and stabilizer elements compose flux gates.

The fluxgates consist of three similar coils on lucite spools mounted perpendicular to each other. The middle coil, held parallel to the earth's field by the two perpendicular coils, is the detector by which the signals are obtained.

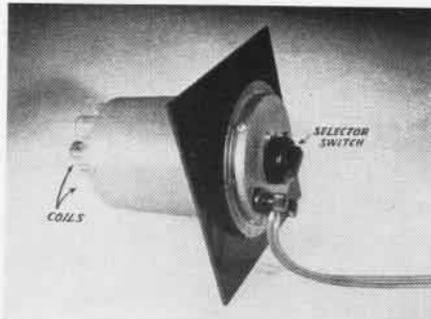
COILS GO IN. SWITCH OUTSIDE PACKAGE

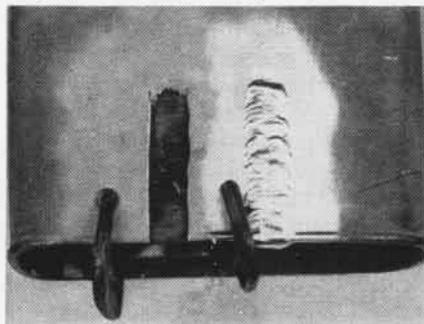
CUT SECTION AND FILL SHOWN IN PHOTO

NAS MOFFETT FIELD—Welding shop employees have developed a new meth-

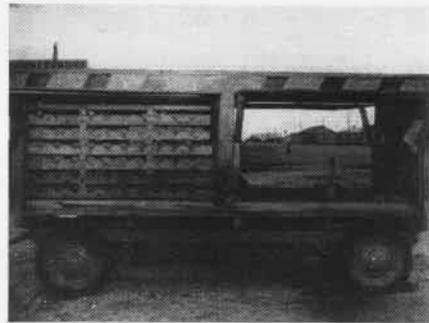
RACKS ON LEFT HOLD ASSEMBLED ROCKETS

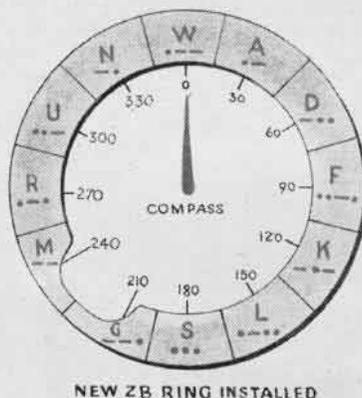
IMPROVED ZB YOKE FACILITATES HOMING

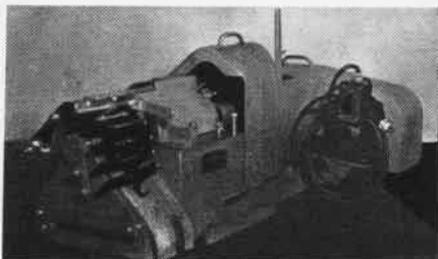
PHOTO SHOWS MACHINE SET FOR DELINKING
