NAVAL AVIATION

# NEWS

MARCH 1949

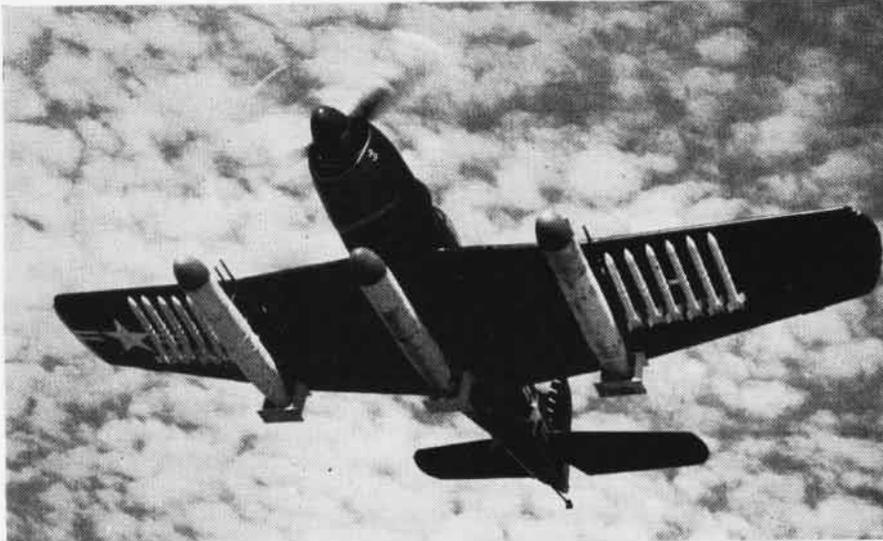
Take a good look at the armament the plane above is carrying—three aerial torpedoes, 12 HVAR rockets and four 20 mm cannon—a total of 9,000 pounds. Weight of the AM-1 Mauler pictured was 25,520 pounds, considerably heavier than a conventional twin-

engine R4D. The Navy is buying 149 of these big dive bombers from Glenn L. Martin, about a third of them yet to be delivered. A P&W Wasp Major engine powers the Mauler turning out 3,000 hp. The AM-1 can gross up to 29,000 lbs. if the need should arise.

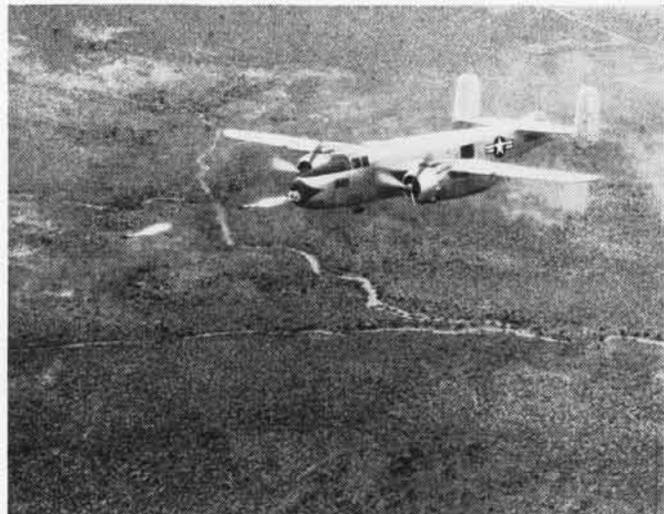
PBJ FIRES SPIN-STABILIZED 5" ROCKETS FROM TUBES IN PLANE NOSE

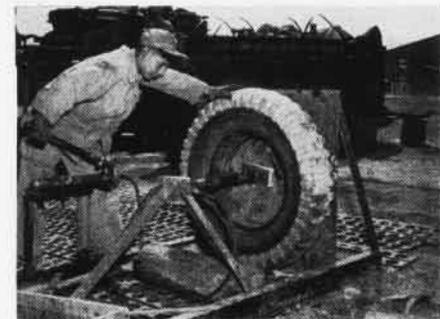
HYDRAULIC JACK WORKS TIRE REMOVAL DEVICE

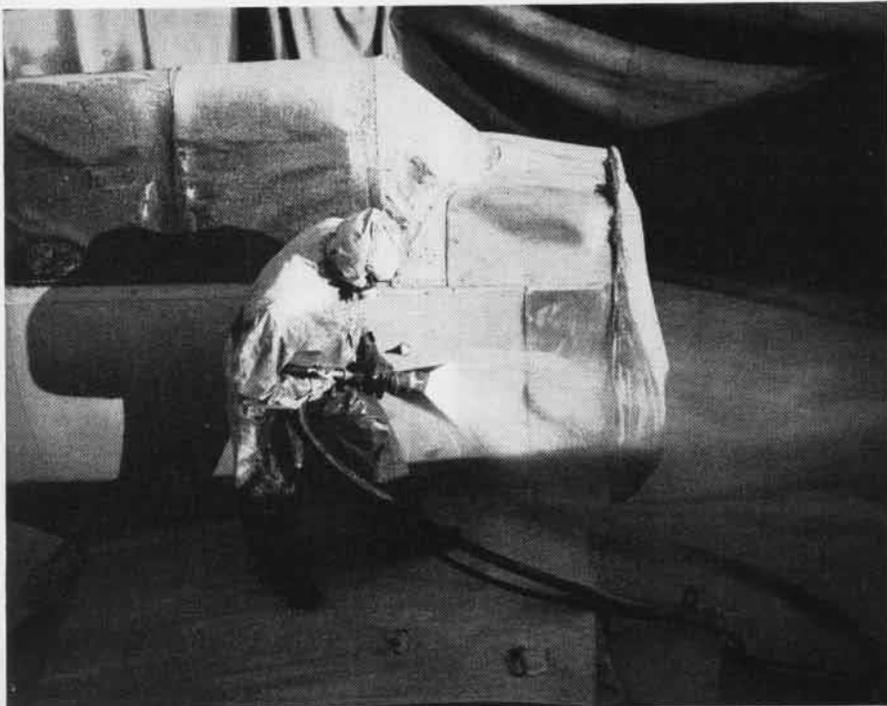
VAPOR BLAST PROCESS BEING USED ON SNJ AIRCRAFT AT ALAMEDA; NOTE PROTECTIVE MASKING

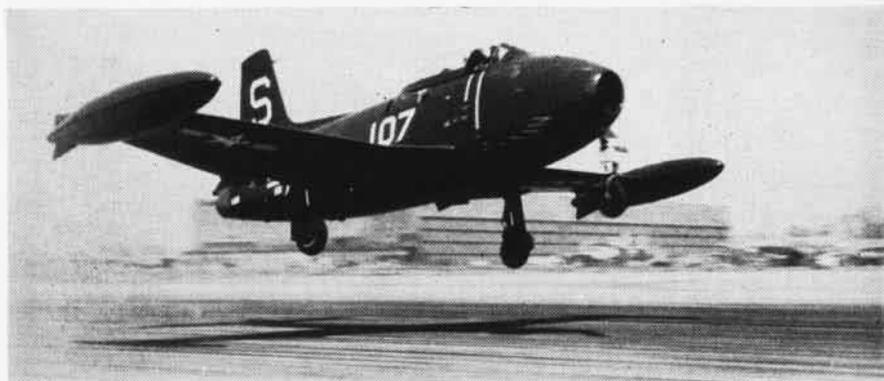
Those sizeable wingtip tanks on the FJ-1 from VF-51 were added to give it range to compete in the Bendix air race last fall. Photo shows it taking off at Long Beach with the 290-gallon tanks filled with JP-1 fuel, sufficient to complete the 1800-nautical mile non-stop flight at 96% RPM. The plane otherwise was in a standard combat configuration and carried a partial ammunition load. Its take-off weight of almost 18,000 lbs. is believed a record for single engine jet aircraft.

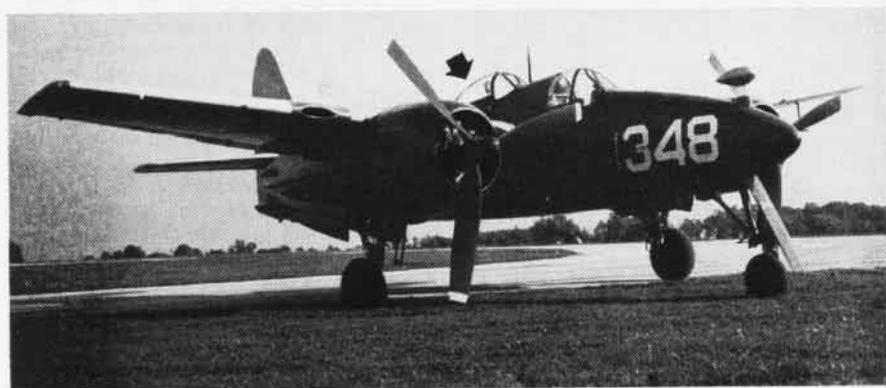
The above photo shows the new-style after cockpit which BuAer has placed on the F7F-2D airplane. Designed to provide adequate visibility for air control of pilotless aircraft, it gives the Tigercat a new look. The modification consists of an F8F windshield and bubble canopy installed over the rear cockpit and the use of a standard type pilot's seat. Utility Squadron Three is giving it service evaluation.
